**Bundesstelle für Seeunfalluntersuchung**  
Federal Bureau of Maritime Casualty Investigation

## **Occupational Accident Involving Chemicals on Board the LNG Tanker CORALIUS in the Port of Travemünde on 5 August 2024**

Investigation Report 385/24

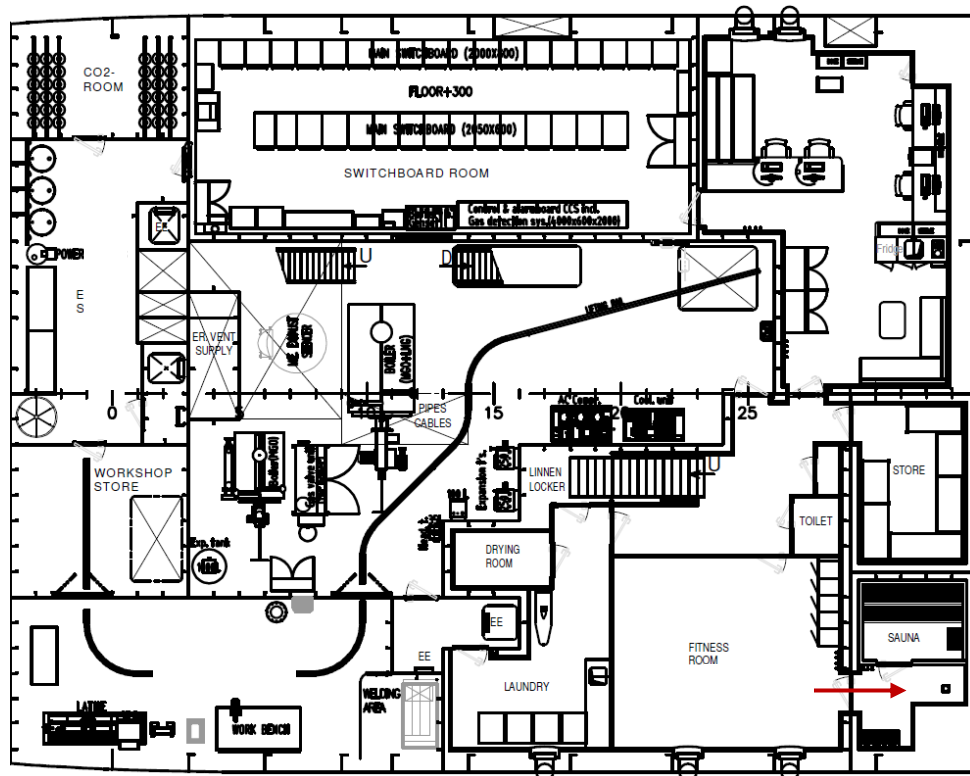
Figure 5: ECR deck<sup>11</sup>

The C/E again tried to reach the platform deck but had to turn back due to the intense and irritating smell. He later found the Motorman in the shower of the gym, located close to the workshop on the same deck (cf. Figure 5), with the 1/E present. The Master also came down to inquire about the situation, but the C/E could not provide details at that time.

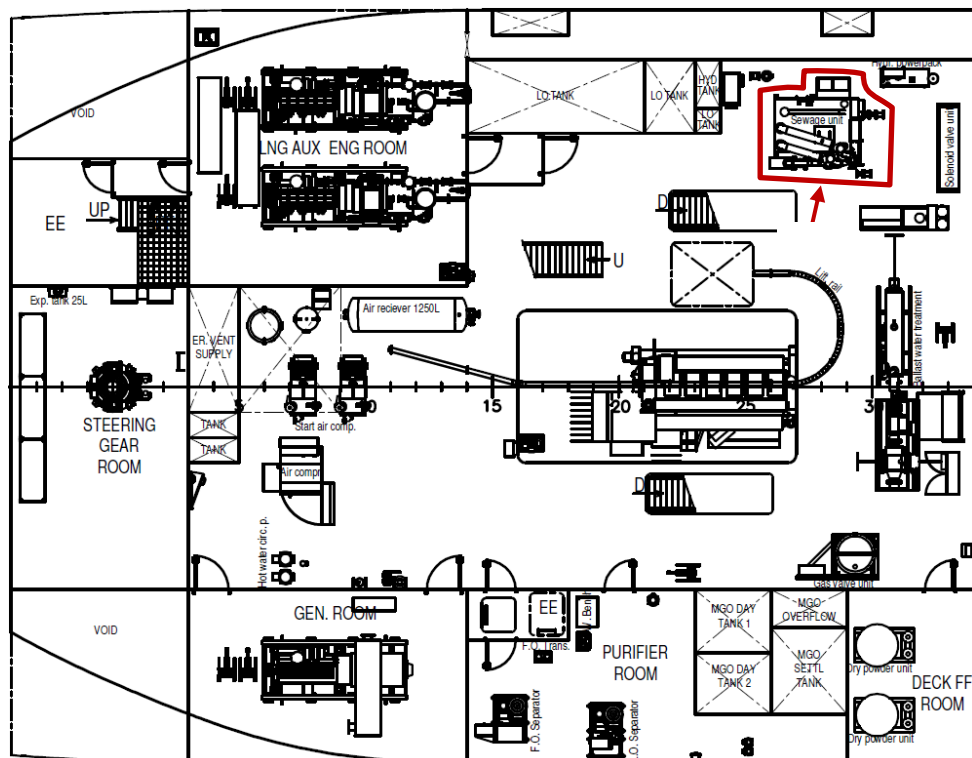
Figure 6: Platform deck<sup>11</sup>

therefore refilled next to the plant instead, where there is more open space (cf. Figure 6 and Figure 13). According to the STP manufacturer's installation instructions, access to the chlorination and dechlorination dosing tanks must be arranged when installing the plant on board.<sup>30</sup> "No need for modification of these tanks and their placement had previously been identified."<sup>31</sup>

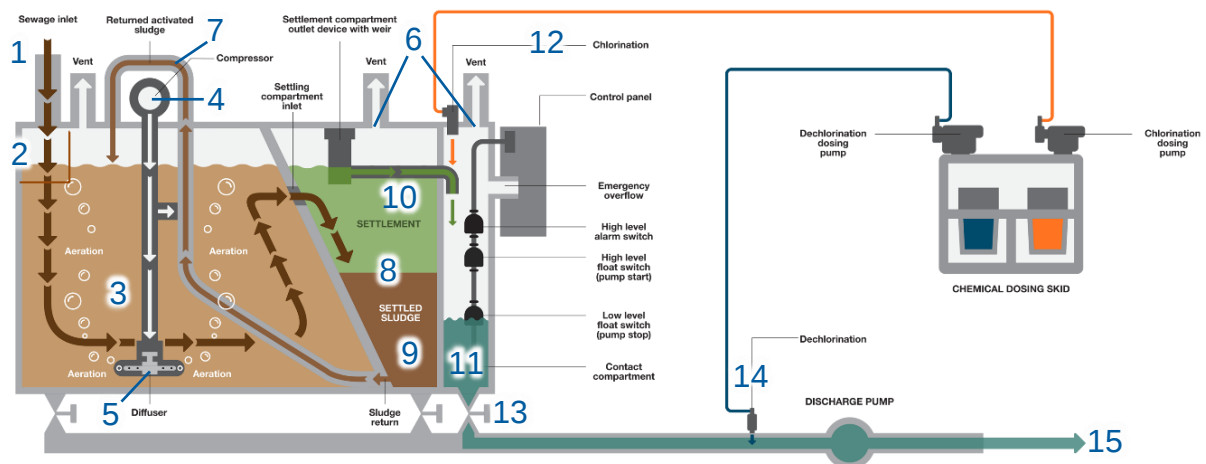
Figure 8: STC03-13 process flow<sup>23</sup>

The raw sewage is collected via a vacuum-fed inlet (see [No. 1](#), Figure 8), which is designed to handle both “black water” (from toilets) and “grey water” (from showers, sinks etc.). The vacuum system ensures efficient transfer even in moving shipboard environments.

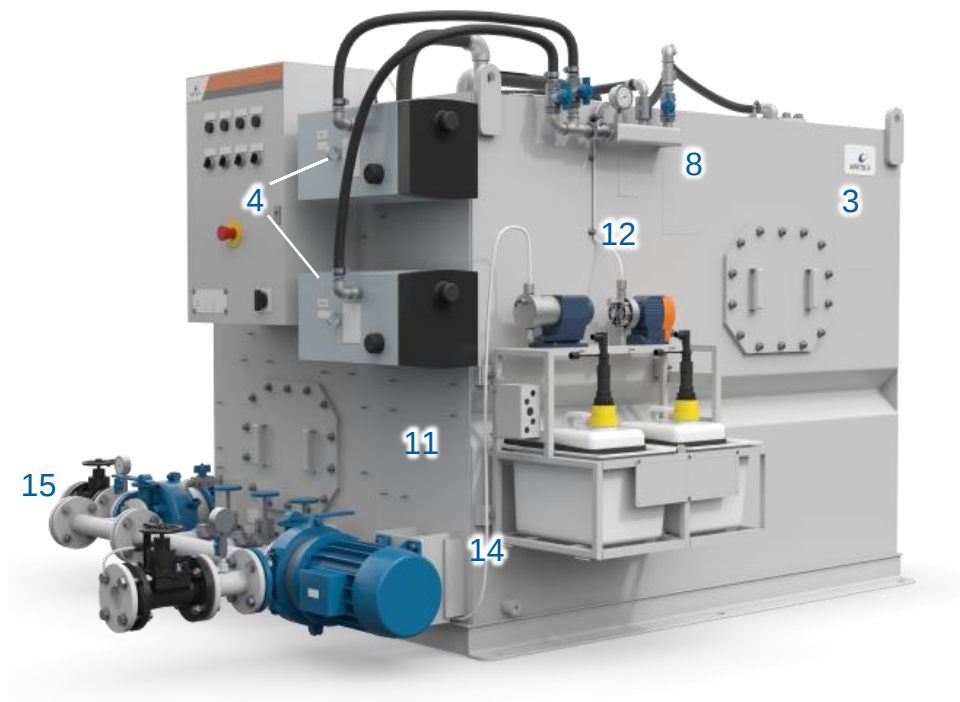
Figure 9: STC03-13 plant<sup>24</sup>

CORALIUS was the only vessel in its company's fleet using this type of STP which requires the use of both NaOCl and NaHSO<sub>3</sub> solutions.

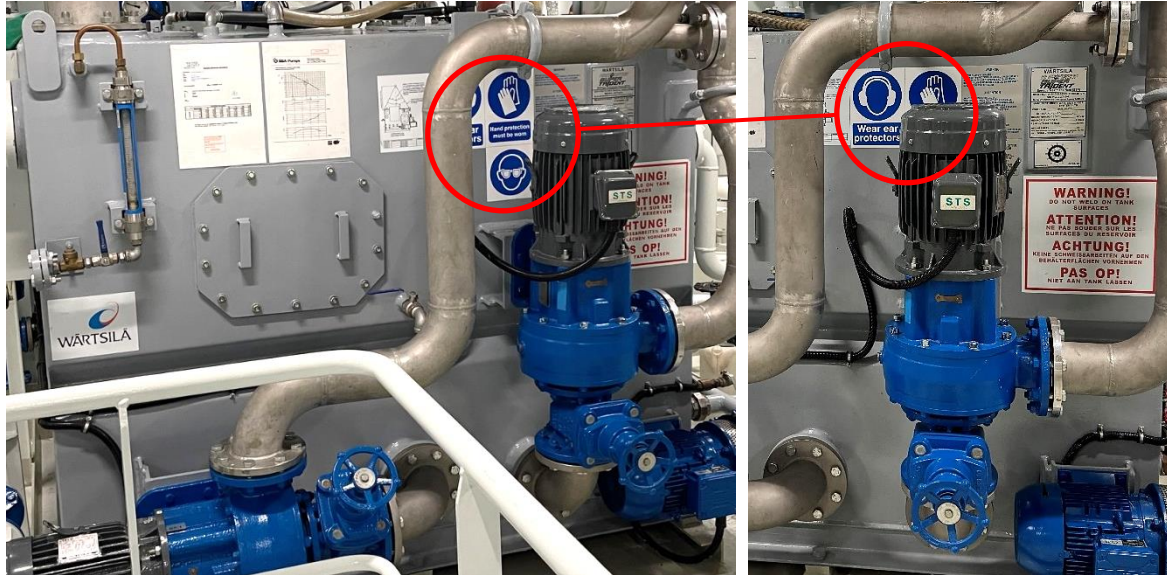
Figure 10: Mandatory action symbols on STP<sup>25</sup>

On the STP, there were different safety signs and warnings. These included the mandatory action symbols for wearing ear, hand and eye protection.

The symbols for eye and hand protection were repeated on signs attached to the front of the dosing tanks' holder (cf. Figure 3 and Figure 11). These also show

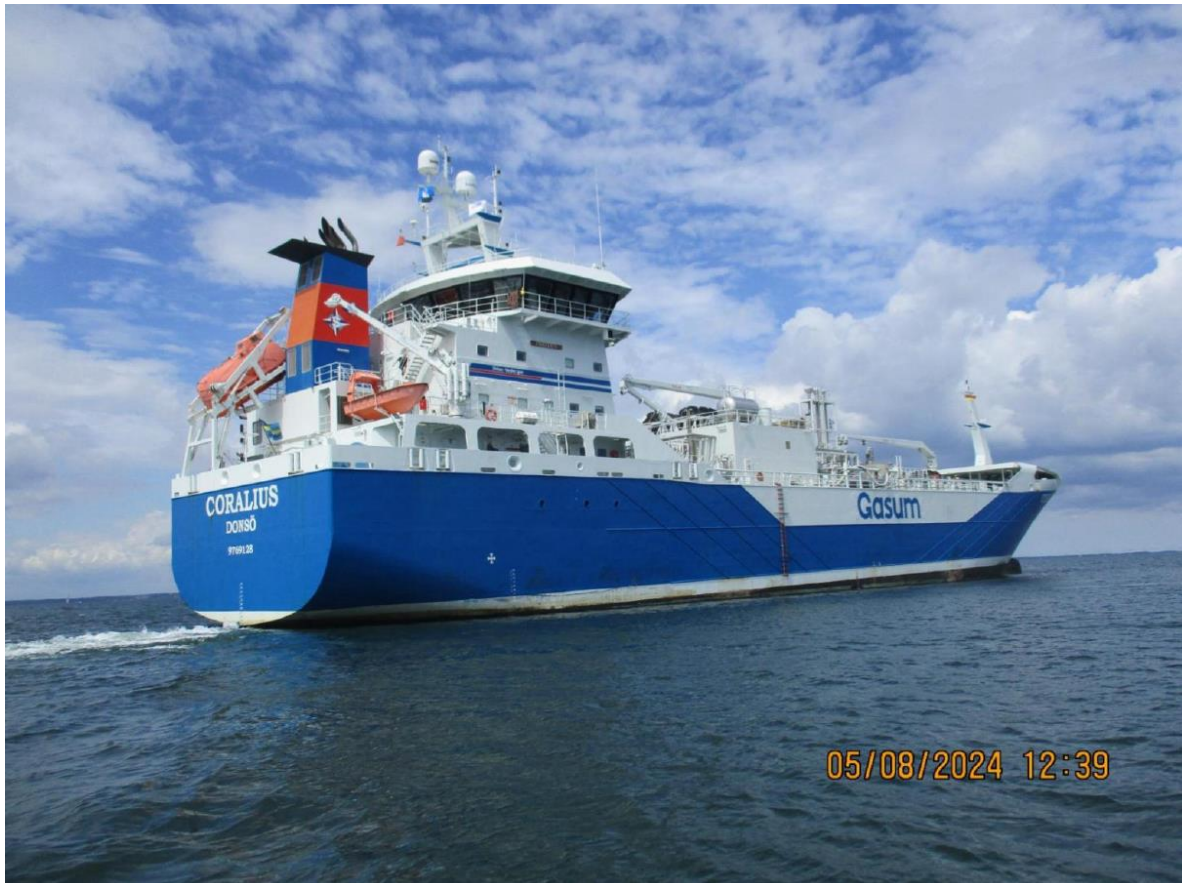
Figure 16: Weather conditions in the Bay of Lübeck after the accident<sup>55</sup>

When the Motorman disembarked, it was partly cloudy without precipitation, and air and water temperatures were at 21 °C. In the Bay of Lübeck, a light westerly breeze (2 Bft) with gusts of 3–4 Bft prevailed. The significant wave height<sup>53</sup> in the area did not exceed 0.4 m. Surrounding weather stations reported good visibility of more than 17 nm.<sup>54</sup> The following picture was taken about one hour after the Motorman had disembarked.
