REPUBLIC OF ESTONIA
SAFETY INVESTIGATION BUREAU

Final Report of Preliminary Assessment of New Findings on MV ESTONIA Accident

Tallinn

2025

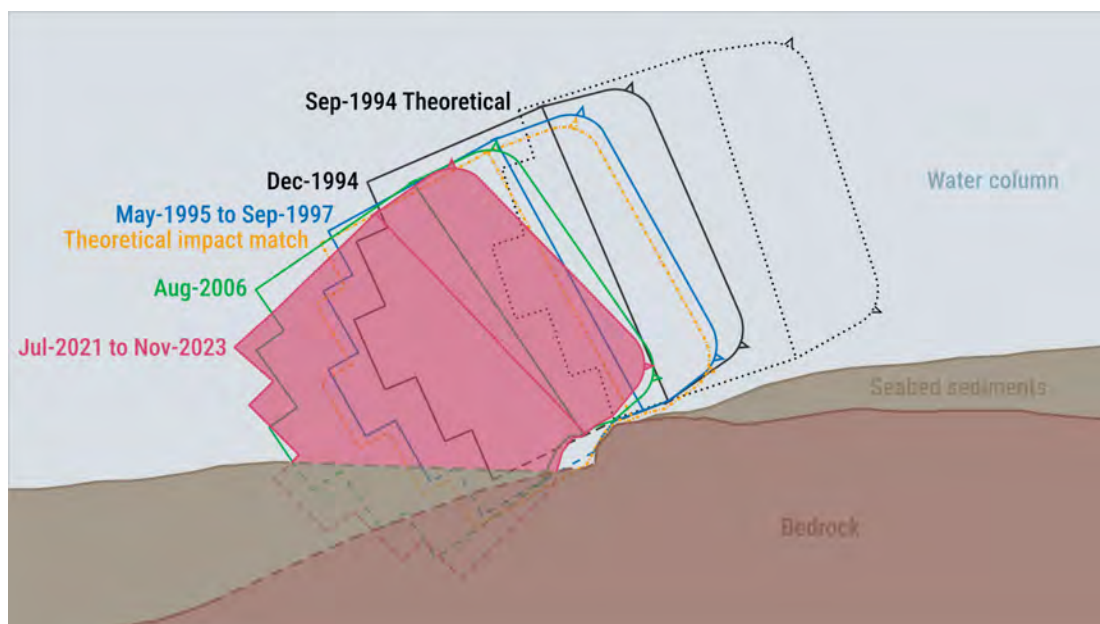
The ROV footage showed that the wreck had extensive damage. The starboard side, previously hidden towards the seabed, now showed an indentation, approx. 25 m of length, which at each end form a breach through the hull into the vessel's interior. The indentation followed the bedrock ridge well. Amongst other damage, the most obvious were a bending, partly a rupture, reaching from the aft part of the vessel's port side towards almost half of the vessel's length; the navigation bridge on port side heavily pushed down to the deck below; and the forward car deck ramp loosened from the remaining two (out of four) hinges and fallen down into the clay at the vessel's side.

FIG. 0.2: A sectional cut at midships, near the forward penetrating damage, illustrates the wreck's movement over the decades.

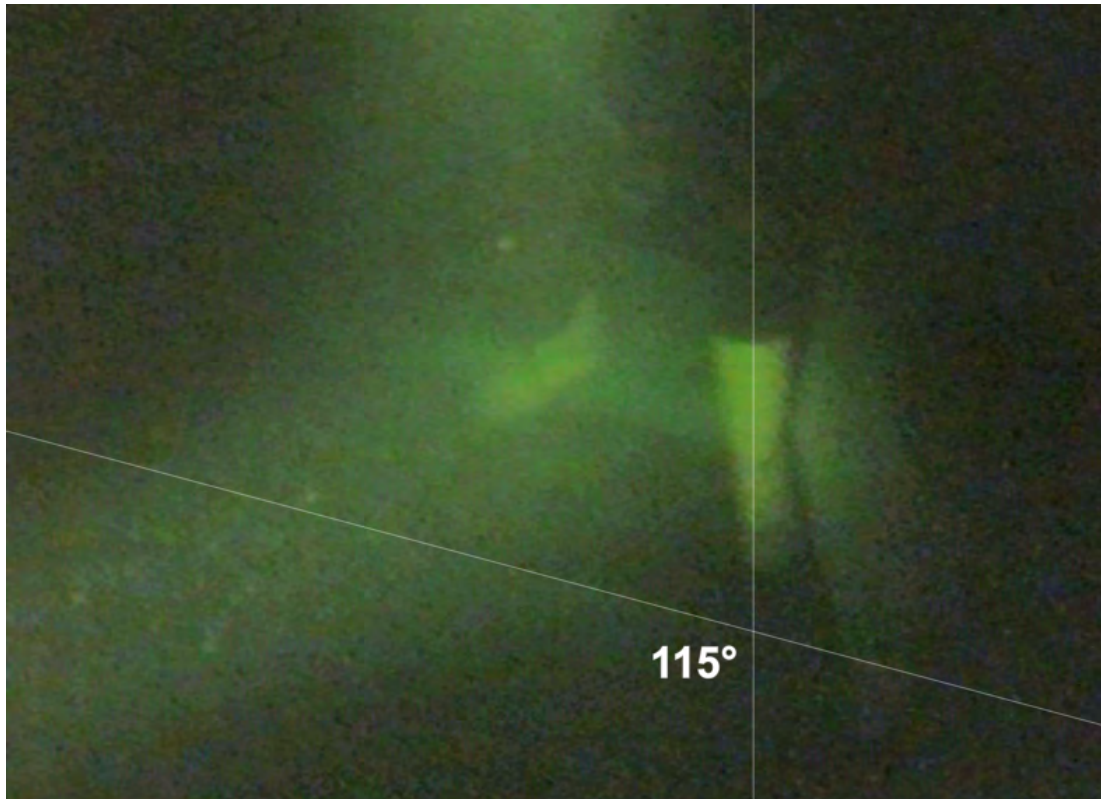
FIG. 3.22: A diver standing on an accommodation deck window on the port side of the wreck in Dec-1994. If the left support leg is considered as the line of gravity, the wreck's heel angle is estimated to be approx. 115° based on the window's orientation. Still from recorded videos.

survey, while [earlier assessments](#) suggested a heel angle of 115° , likely based on ROV imagery of the front bulkhead.[18] Additionally, the [ter Haar report](#) stated that there was “little to no” trim angle.[5, Sec. 3.a.] An ROV image showing a diver standing on the port side of the wreck also supports a heel angle of approx. 115° ([Figure 3.22](#)).

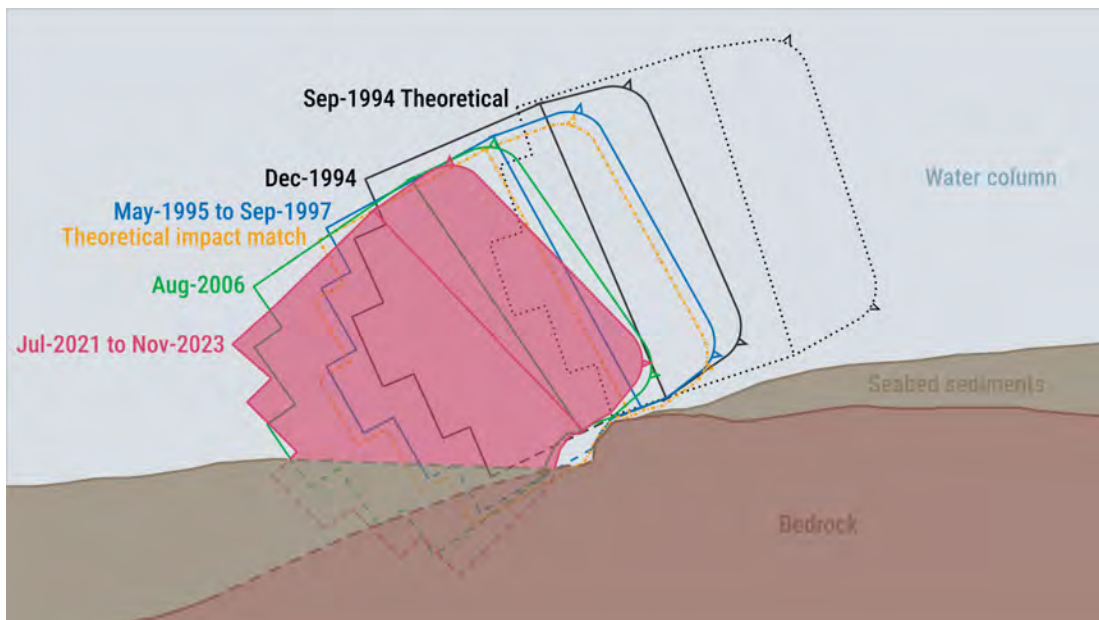
FIG. 3.27: A sectional cut at midships, near the forward penetrating damage, illustrates the wreck's movement over the decades.

Over the decades, as the wreck has shifted and rotated down the slope, deformations have expanded, particularly on the port side.

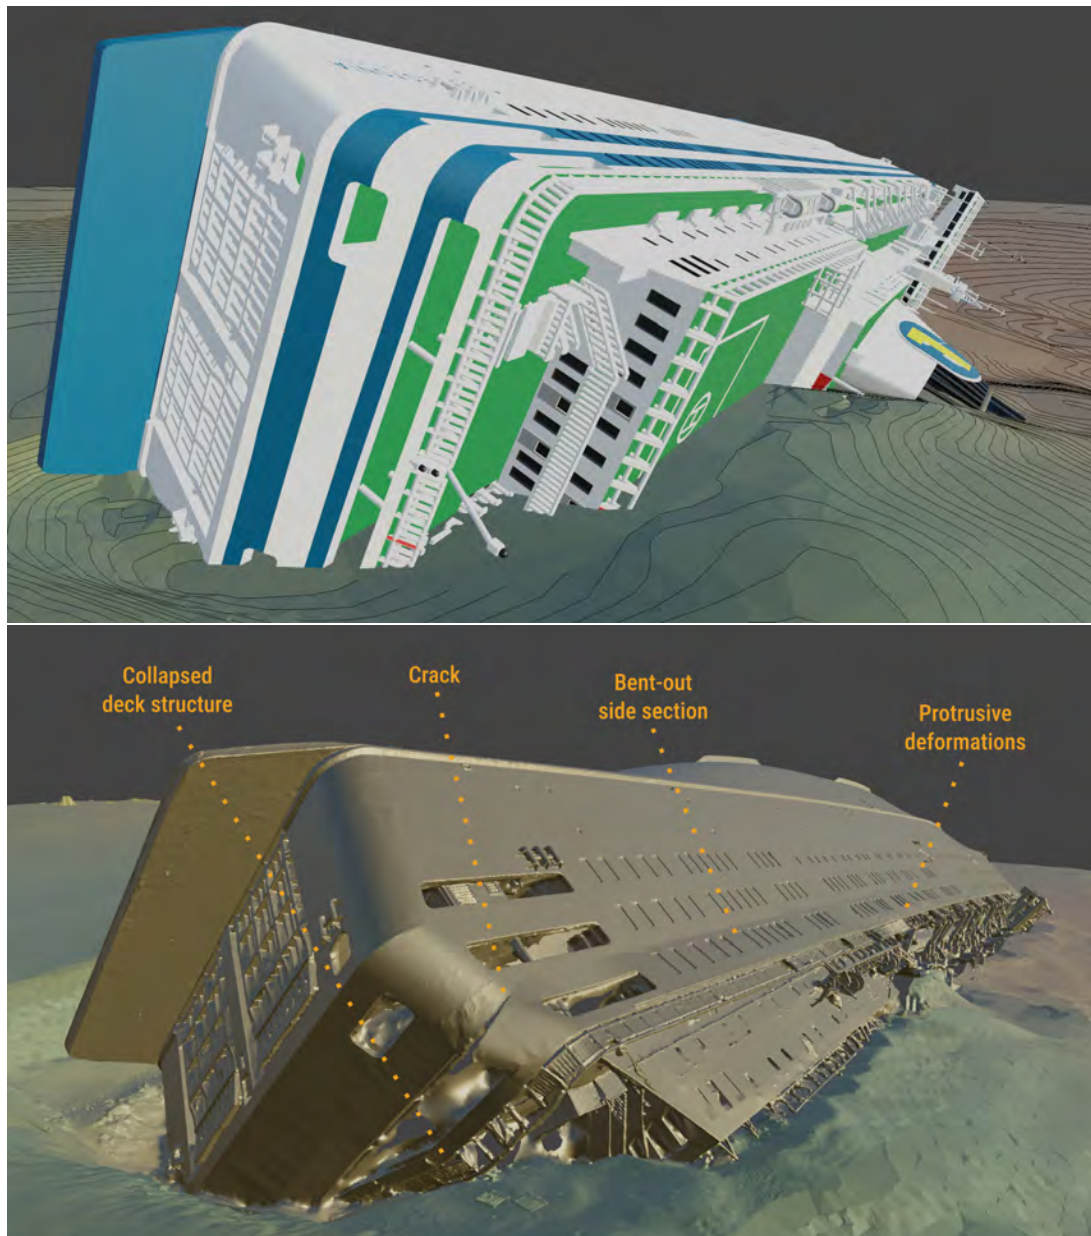
- The accommodation decks in the stern of the wreck are severely deformed, with a large crack at the rounded stern corner at the level of Deck 6 (Figure 3.28). This deformation continues from the stern to the originally flat port side, where the upper section above Deck 6 is bent outward. The port-side deformation is most pronounced at midships and gradually diminishes towards the bow.

FIG. 3.28: Above: Stern view of the reconstructed wreck position in Dec-1994 resting on digitised bathymetry from Jan-1996. More than half of the helicopter deck was visible then, which now has completely submerged into the seabed because of the wreck movement. Below: Stern view of the photogrammetric model of the wreck illustrating the observed structural damage.

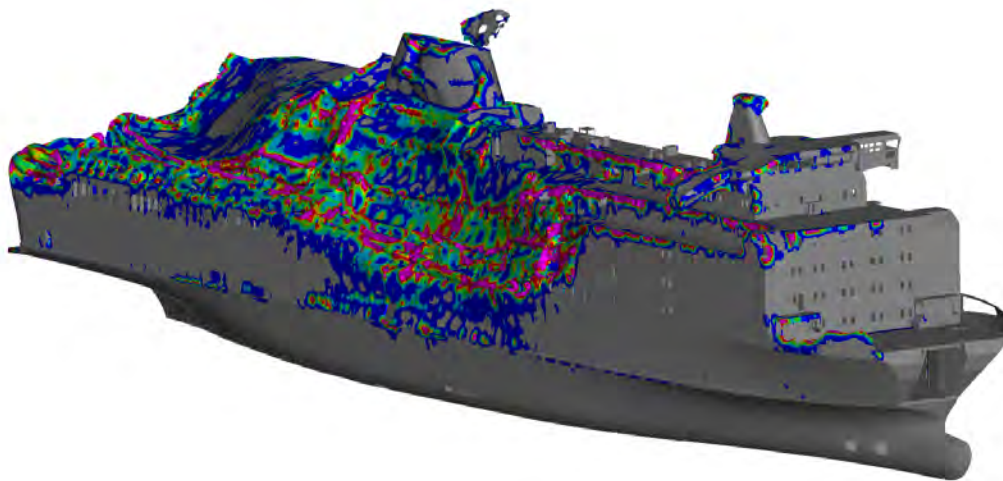
The objective of the FEM modelling was not to replicate the damage visible on the wreck today, but to observe how the ship would behave in a theoretical collision with the seabed.

FIG. 3.32: Wreck deformations on theoretical FEM model after the bottom contact illustrating the possible extent of wreck structural damage. Source: Tabri et al. [44].

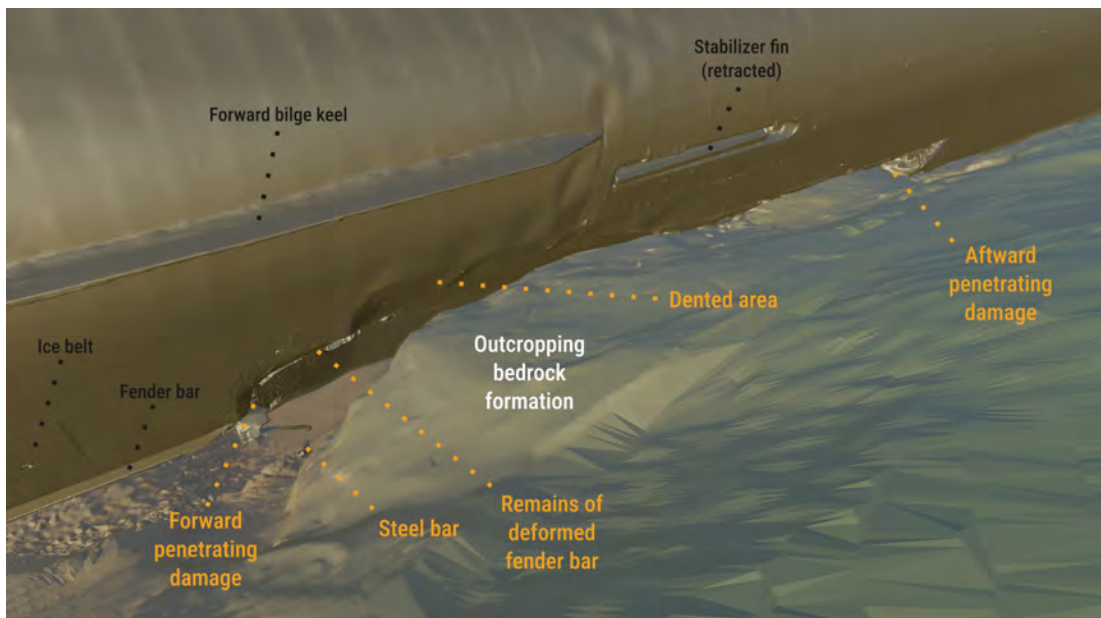
FIG. 3.34: Wreck side damage and the corresponding seabed on the digital model.

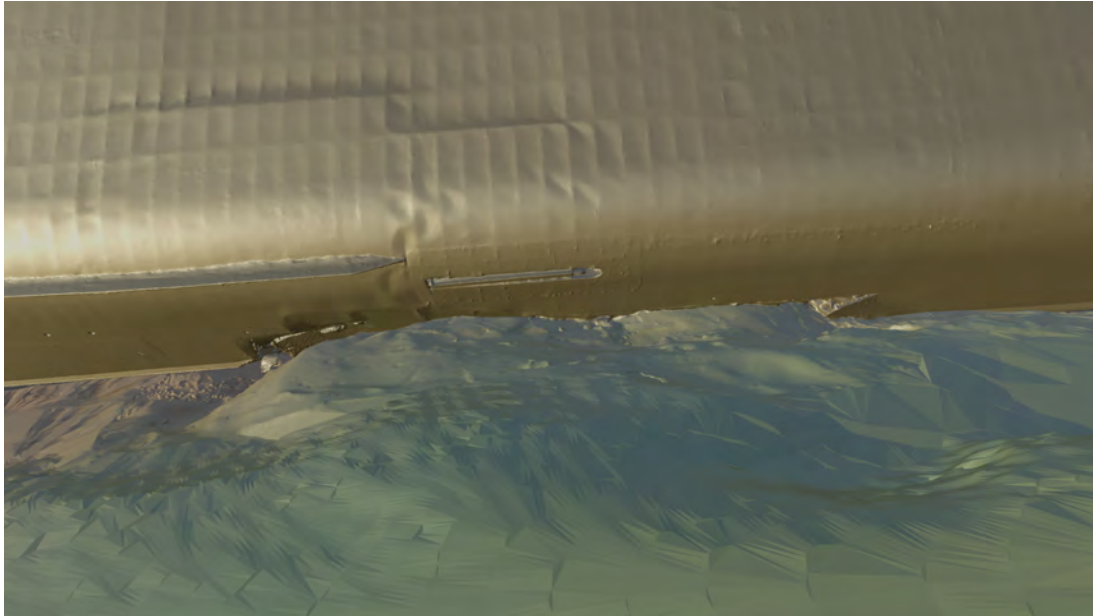
FIG. 3.35: Wreck side damage and the corresponding seabed on the digital model, side view.

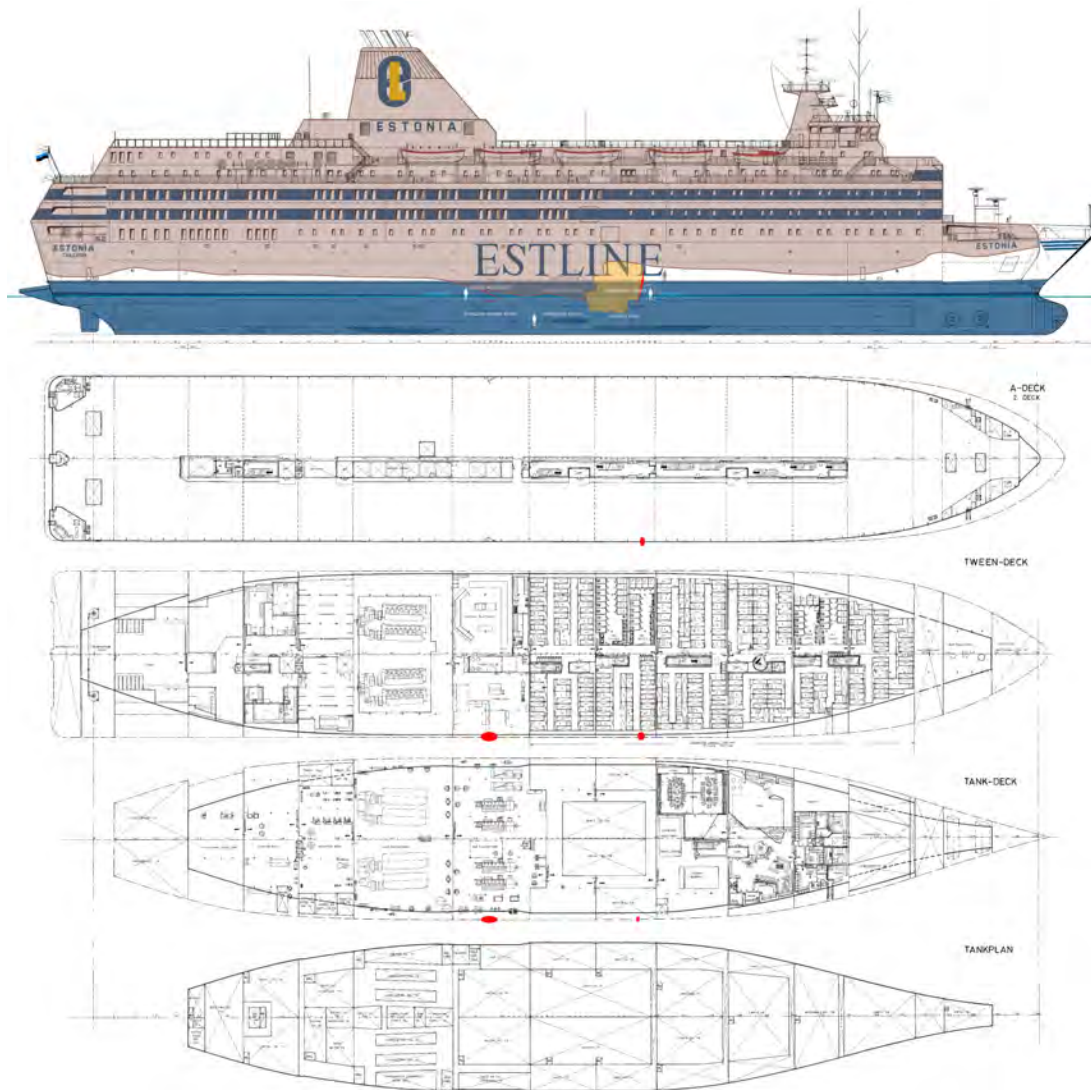
Since the wreck's underwater hull is fully documented in the photogrammetric model, it can be concluded that the underwater hull is intact, except for a single crack

extending to the design waterline from the forward penetrating damage and, partly, the aftward penetrating damage located at the design waterline level (Figure 3.38).

FIG. 3.38: Wreck mudline in the current orientation. Light brown area on the vessel's general arrangement is in contact with seabed. Penetrating damage is marked by red and dents in yellow.

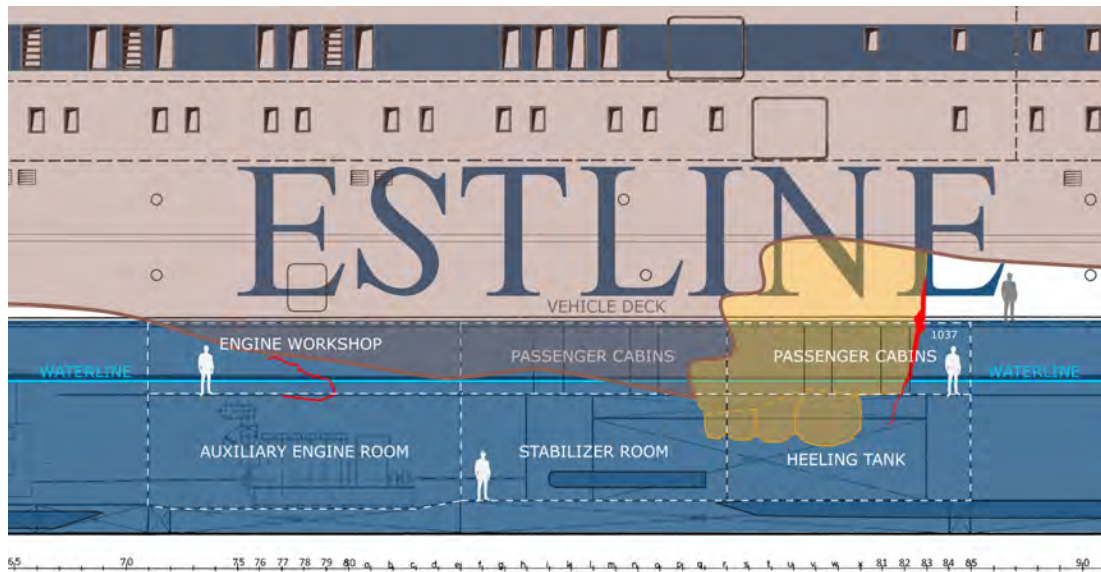
FIG. 3.39: Detailed view of the mudline and side damage. Light brown area on the vessel's general arrangement is in contact with seabed. Penetrating damage is marked by red and dents in yellow.

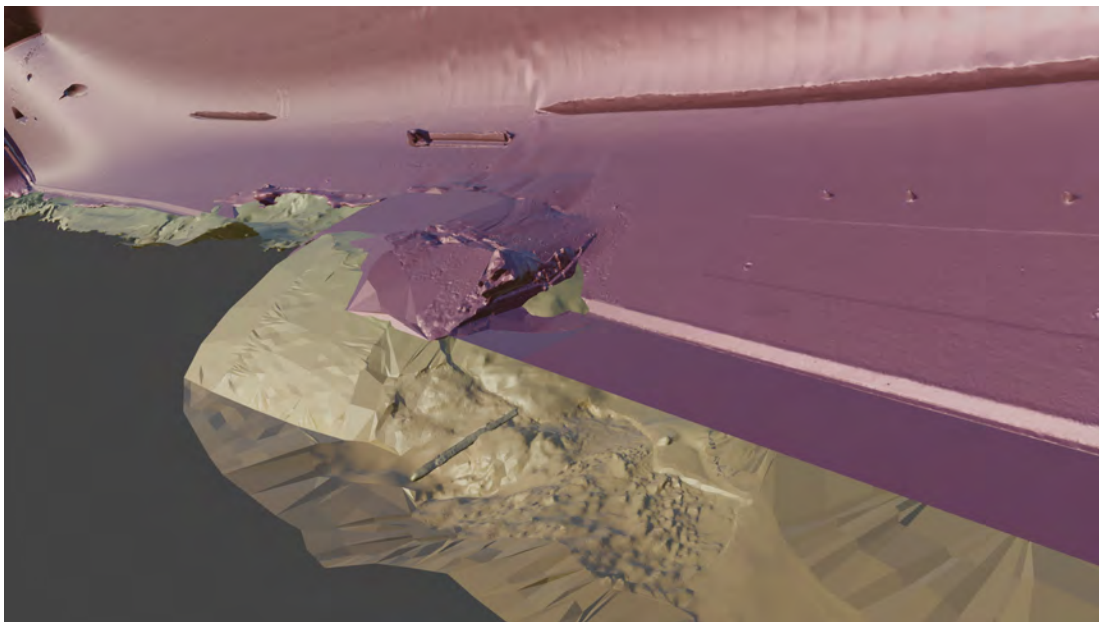
FIG. 3.40: Photogrammetric model of the wreck (purple) shifted and turned upwards to match the contact between the starboard side deformations and the bedrock formation (brownish). This alignment corresponds to the orientation slightly downhill from Sep-1997 orientation. The wreck is shown primarily as measured during the photogrammetry survey (O 2.20); as the photogrammetry did not image below the seabed layer, the parts of the wreck currently extending below the seabed are not shown. Also, the view is from inside the wreck, but it is showing the inverted view of the outer surface of the wreck not the actual inner structure.

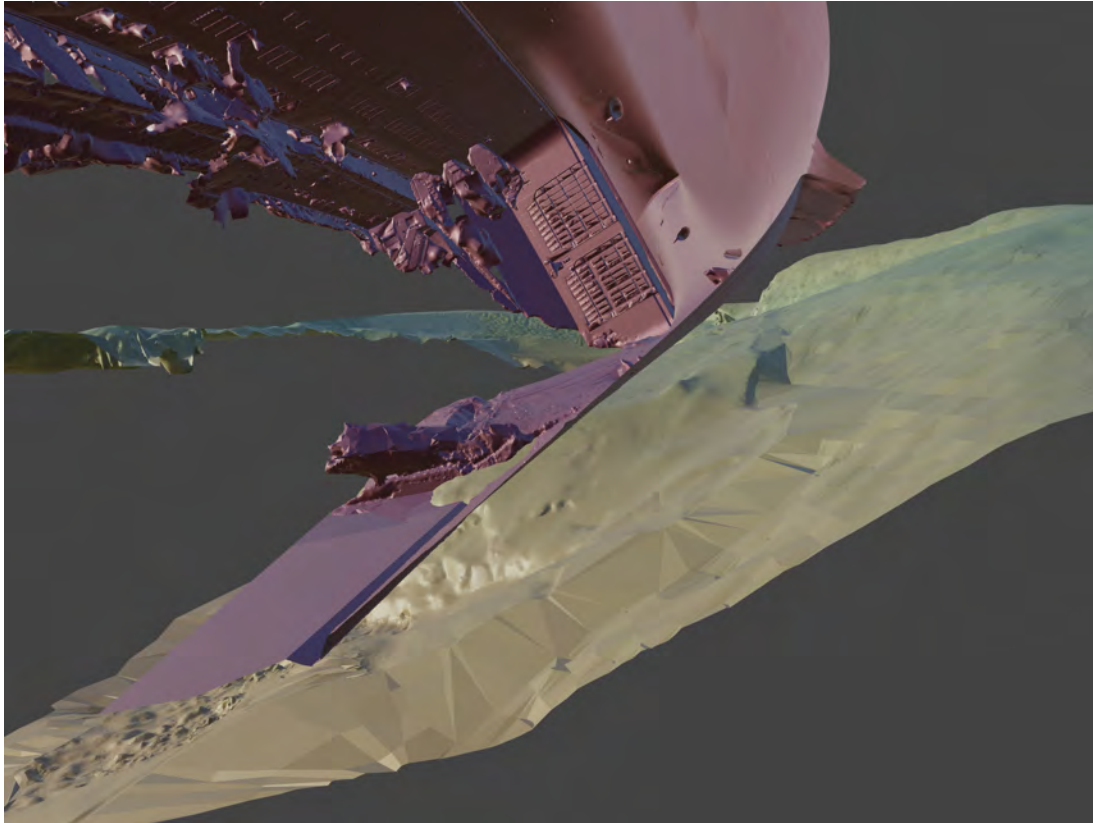
FIG. 3.41: Photogrammetric model of the wreck (purple) shifted and turned upwards to match the contact between the starboard side deformations and the bedrock formation (brownish). This alignment corresponds to the orientation slightly downhill from Sep-1997 orientation. The wreck is shown primarily as measured during the photogrammetry survey ([O 2.20](#)); as the photogrammetry did not image below the seabed layer, the parts of the wreck currently extending below the seabed are not shown. Also, the view is from inside the wreck, but it is showing the inverted view of the outer surface of the wreck not the actual inner structure.

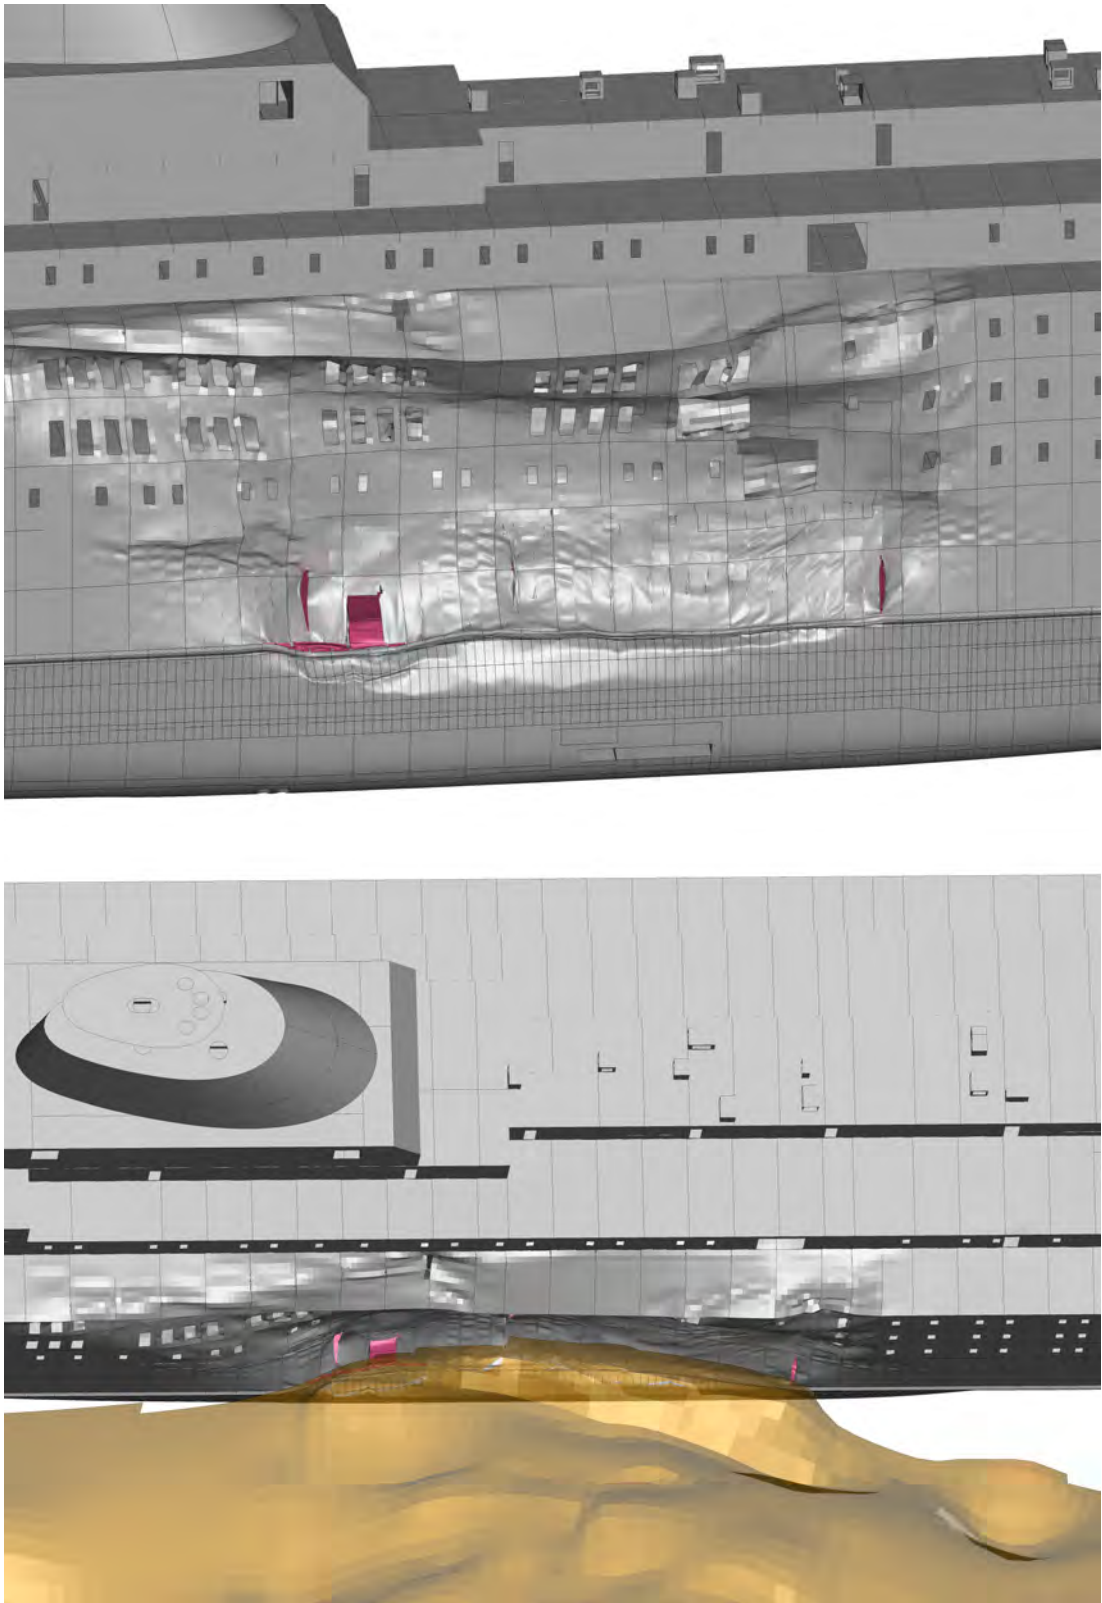
The 3D modelling analysis suggests that it is most likely that the starboard-side damage reached its maximum extent after Sep-1997 and was revealed after Aug-2006 (Figure 3.27). The shape of the starboard-side damage closely corresponds to seabed formations next to the reconstructed wreck positions from May-1995 or later (Figures 3.40 and 3.41). Additionally, numerical assessment of the bottom contact proposes a highly probable scenario of the side damages occurring as a result of the contact between the vessel and the seabed (Figure 3.42).[44]

FIG. 3.42: Wreck deformations on theoretical FEM model after bottom contact with the bedrock. Damage stemming from direct impact with the bedrock under wreck's own weight is illustrated. However, the full descent was not simulated and the full extent of deformations were not included. 'Brown' is the bedrock; 'Pink' illustrates penetrating damage. Source: Tabri and Heinvee [49].

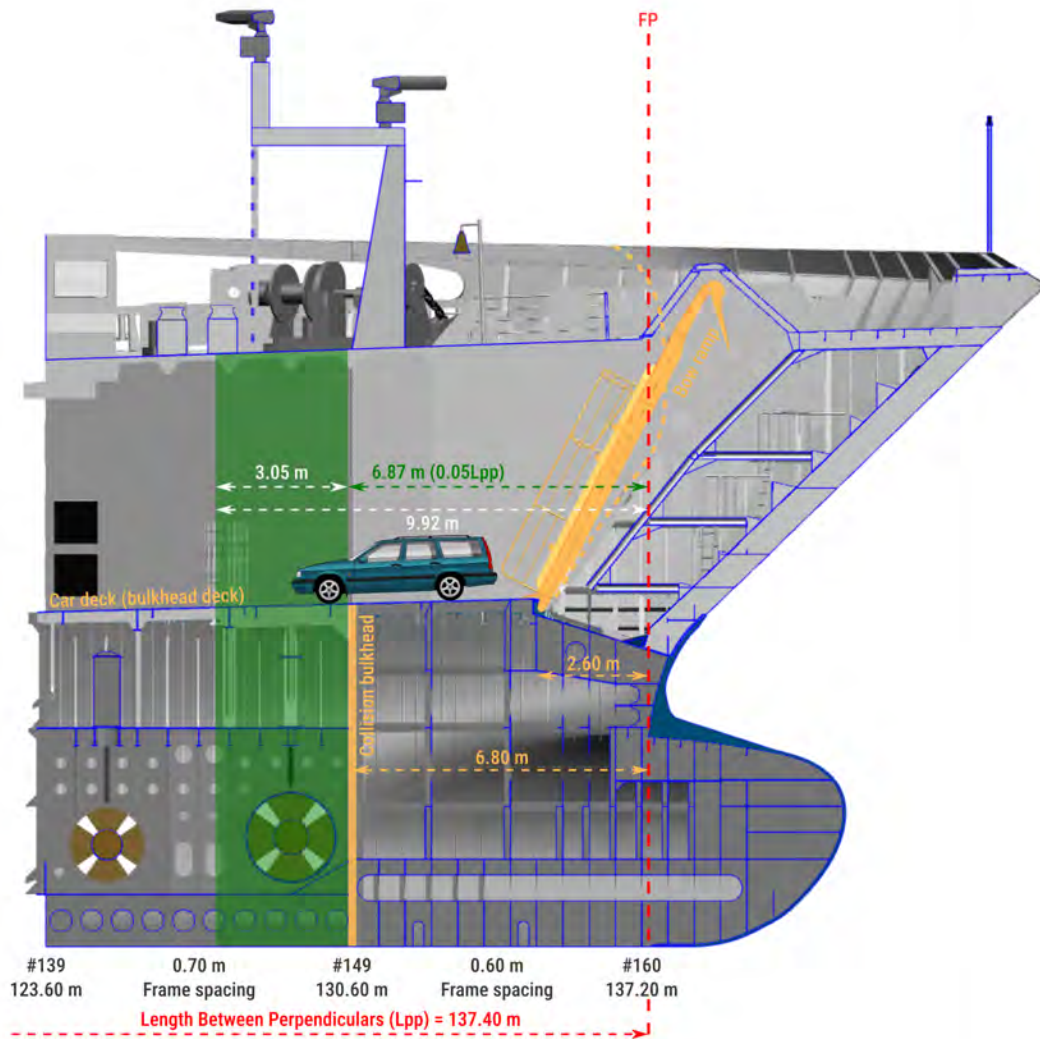
- The requirements of the SOLAS Convention for an upper extension of the collision bulkhead were not satisfied onboard MV ESTONIA (Figure 4.1). These requirements meant that either:

- the exemption⁴ from the SOLAS Convention should have been included in her certificates⁵, which would have restricted her trading area to 20 nm from the nearest land, excluding the Tallinn–Stockholm route. That the restriction was not noted in her certification was a violation of the SOLAS legislation, and another reason for MV ESTONIA to not be seaworthy.

FIG. 4.1: Longitudinal sectional cut of the bow structure of MV ESTONIA. The actual arrangement of the collision bulkhead and its upper extension (bow ramp) above the bulkhead deck (car deck) in 'Yellow'. The required zone for the placement of the forward bulkhead and its extension in compliance with SOLAS 1960 and SOLAS 1974 regulations in 'Green'. This zone depends on the vessel's length between the perpendiculars ('Lpp') and is measured from the forward perpendicular ('FP').

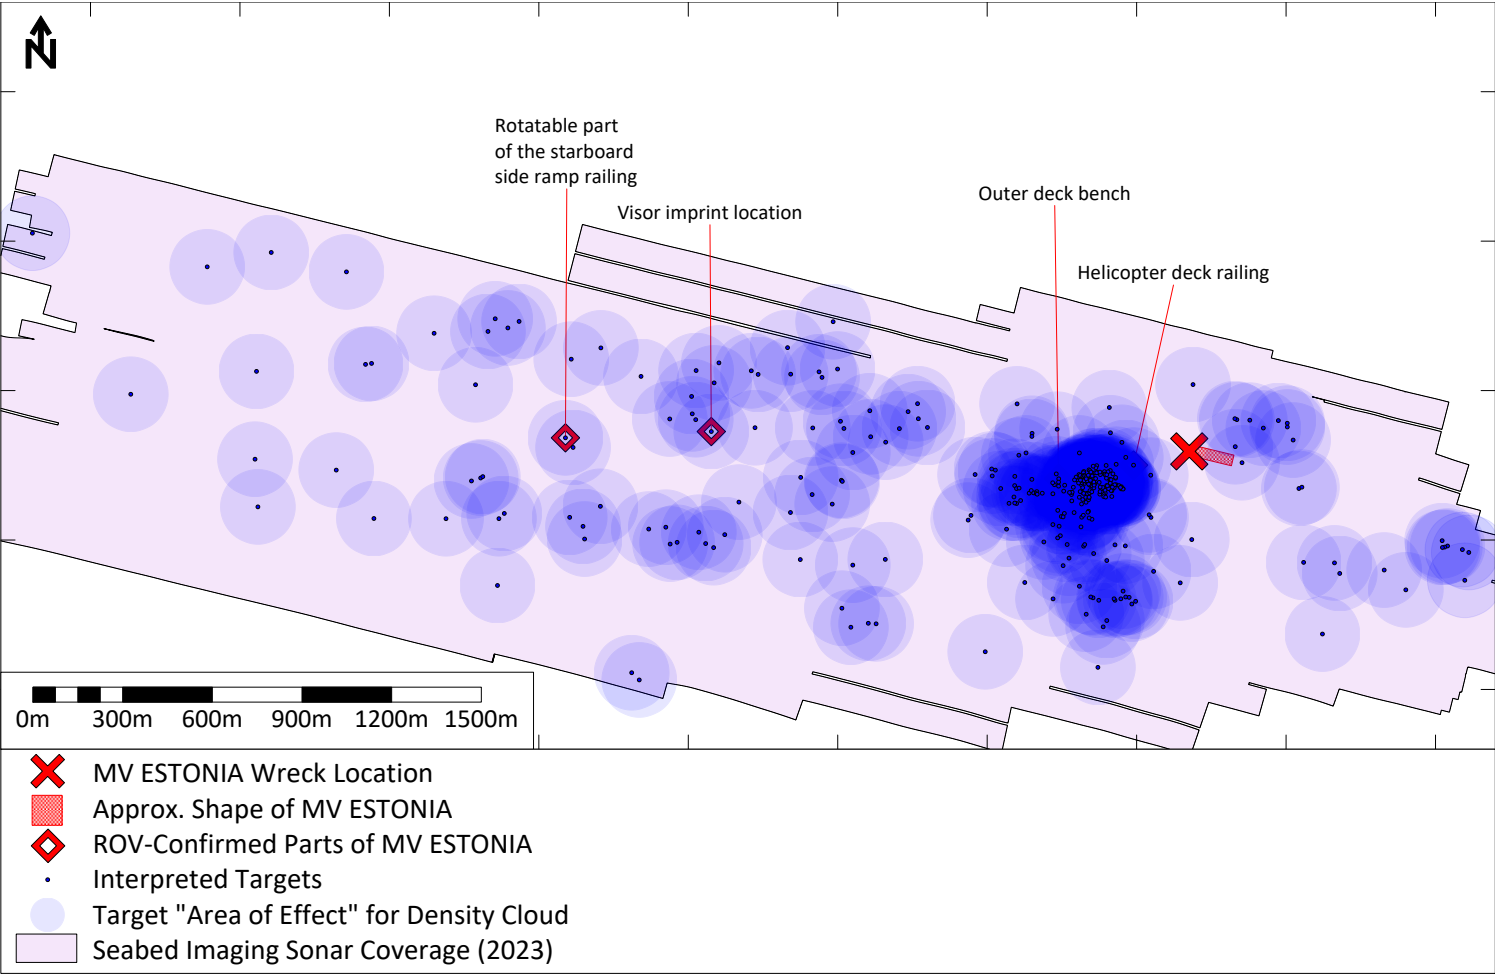
Preliminary Assessment to create a density cloud (Figure 4.3).⁶ Such a method of visualisation reduces the possibility of over-interpreting information from any one individual target.

⁶For clarity, the targets which were identified as natural, i.e., boulders, by the visual inspection (O 2.23) were excluded from the density cloud, presented as Figure 4.3; additional targets were added based on the results of the visual inspection and a check of the MAS seabed representation.[48]

FIG. 4.3: Target density cloud of the debris in the accident area. Almost 300 interpreted anthropogenic objects have formed a basis for reconstructing the vessel's track during the flooding and sinking.

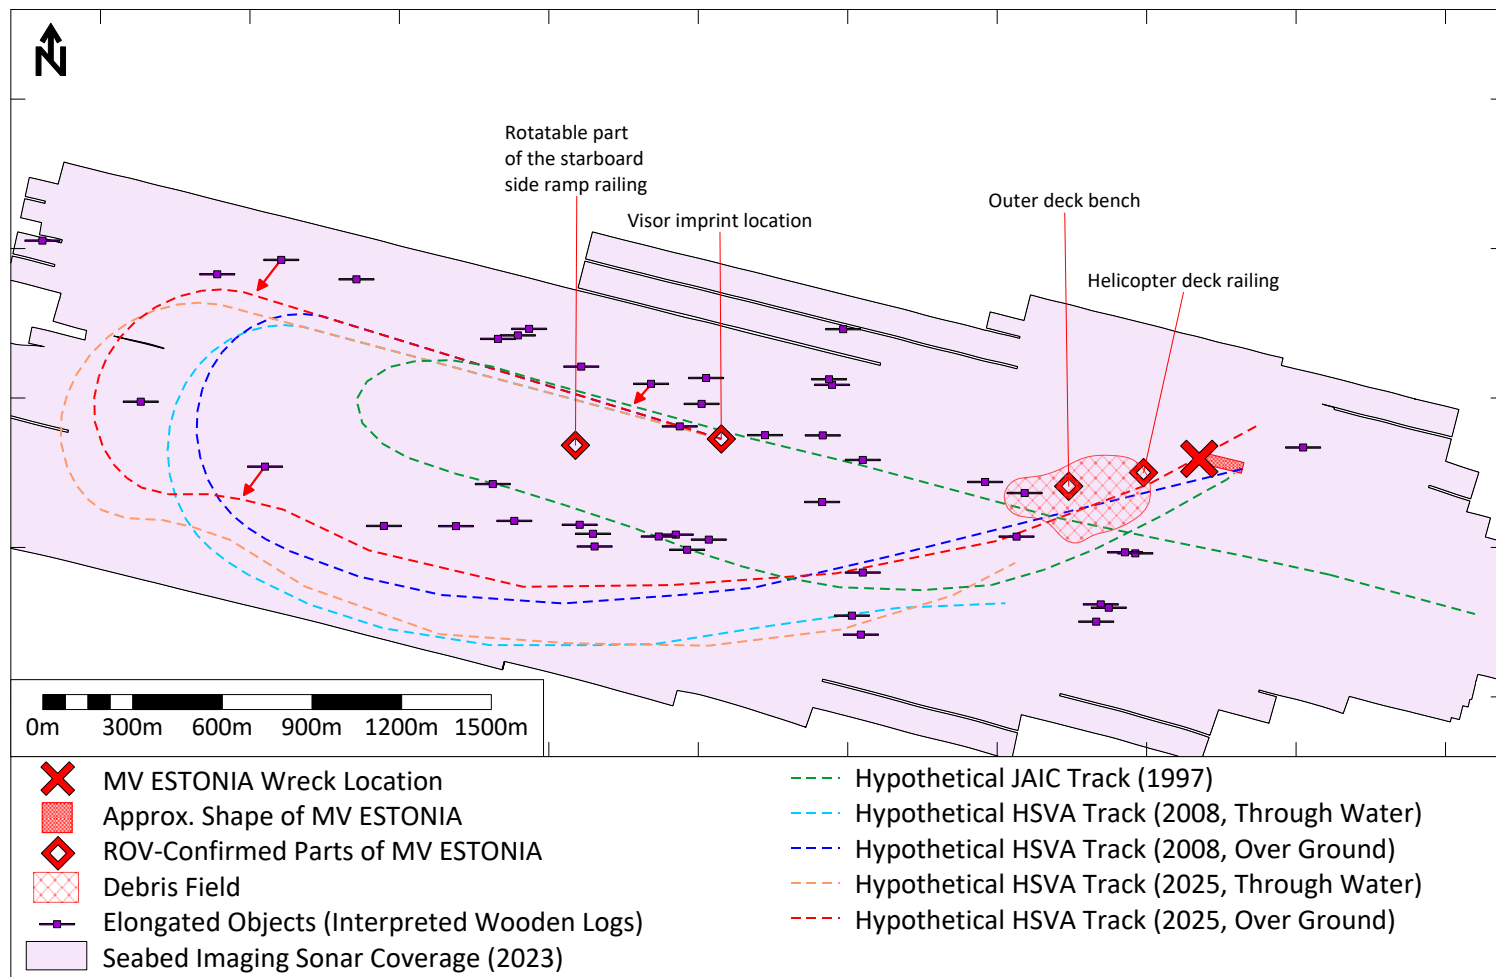
The track reconstructed based on the location of the visor, elongated objects, and the wreck was assessed in numerical sinking simulations completed in 2025 (Figure 4.4).[2] It confirmed that such a track was possible with regards to the timeframe and that it was consistent with expected (modelled) vessel behaviour. Therefore, this is considered the most probable sinking track of MV ESTONIA, based on available information.

FIG. 4.4: Proposed tracks during the flooding and sinking of MV ESTONIA by JAIC, Valanto, and Kim et al.[1], [2], [3] The main reference points of the vessel's track reconstructions are shown.

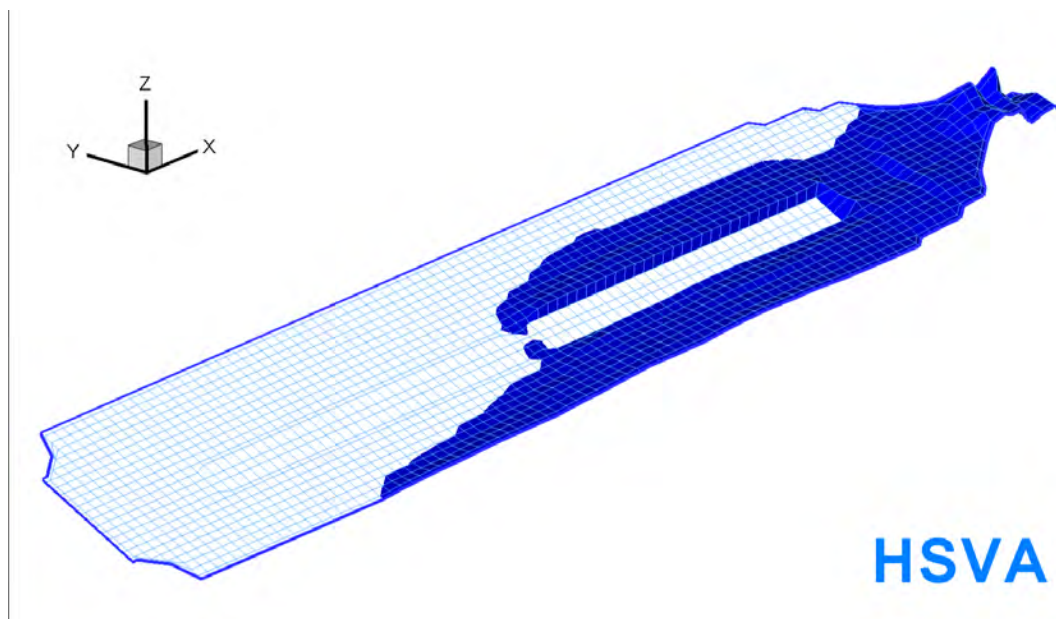
Initially, water spread on both sides of the centre casing and sloshed back and forth between the centre casing and the vessel's sides as the vessel was rolling (Figure 4.6). Water could also have entered the centre casing through lightweight sliding doors, which were neither watertight nor weathertight. These doors had been designed and constructed solely to meet fire protection requirements, hence their designation as fire doors (Figure 4.7). Already by that stage, some water was penetrating through these doors. At least 5 survivors, who began evacuating from below the car deck (Deck 1), observed water running through the gaps around these doors; several other survivors in various sections of Deck 1 also recalled encountering smaller amounts of water on the deck (Section 5.2.3).

FIG. 4.6: Visualization of the numerical flooding process in the HSVA-Rolls program, illustrating the flooding of the car deck from ahead seas: sloshing water is divided by the centre casing (visible walls not included). Accumulation of water to the port side of the centre casing creates water pressure to non-watertight sliding doors (fire doors). Source: Kim et al. [2].

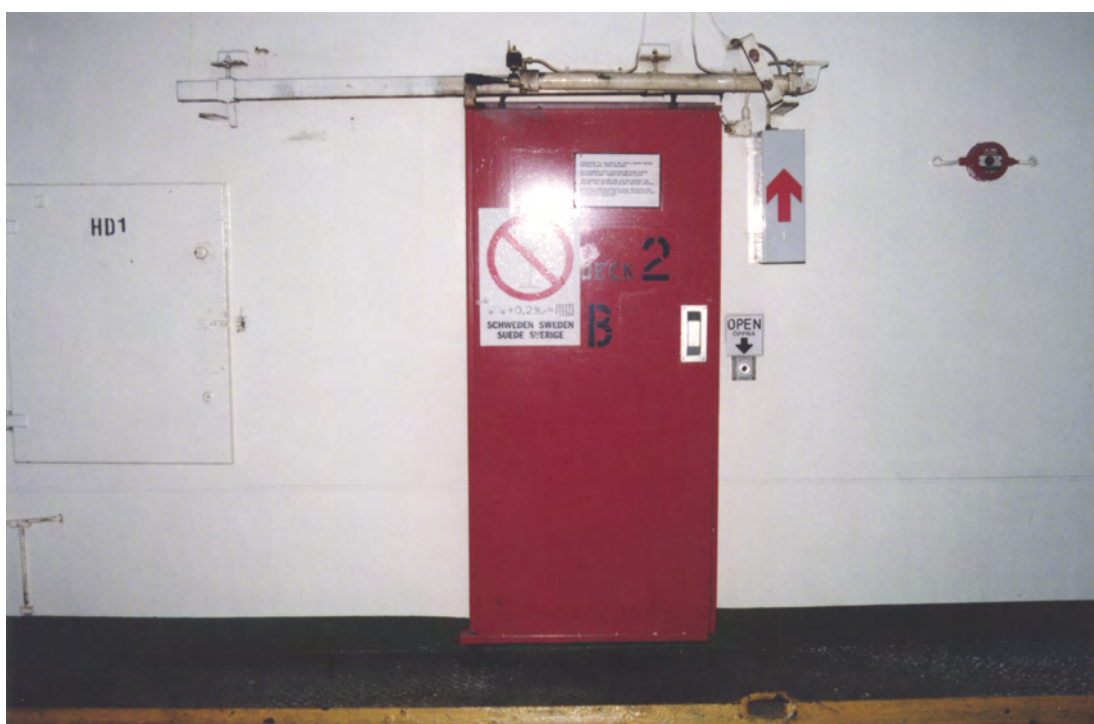
FIG. 4.7: Sliding fire door on the car deck of MV MARE BALTICUM, the near-sistership of MV ESTONIA. Source: Börje Stenström, 1995-11-07, SHK Archives, F 1 HB. 23A B15.6.

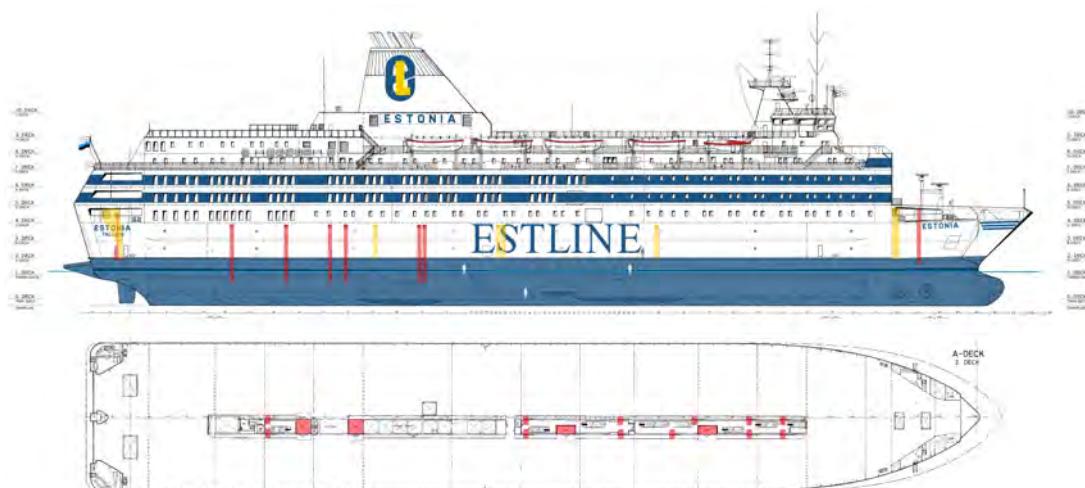
It is likely that after the initial heel developed, the navigators turned the vessel to port through the ahead sea. This may have been an instinctive manoeuvre and an attempt to turn the side that was heeling into the wind. The vessel's turn to port, however, partly contributed to the development of a starboard heel. After the turn, the rate of water ingress through the bow decreased, as the bow opening faced downwind which prevented the rapid capsize of the vessel compared to continuing on the same course. This created an interim stage in the development of the vessel's heel, which allowed several hundred people to reach the weather deck from inside the vessel. Once the turn was executed, ventilation openings located under Deck 4 were submerged, allowing water to enter the compartments below the car deck, including the engine compartments, while also allowing air to escape from these compartments to the opposite side (Figure 4.8). It cannot be ruled out that the ventilation shafts were already damaged by the shifting cargo.

FIG. 4.8: Lowest ventilation openings on the starboard side of the vessel opening to outer shell. 'Red' indicates ventilation channels running below the car deck and 'Yellow' to the car deck. Ventilation channels on other side of the vessel and openings only inside are not shown. Non-weathertight sliding fire doors and elevator doors on the first level of car deck in 'Red'. Other doors and hatches on the car deck are not highlighted.

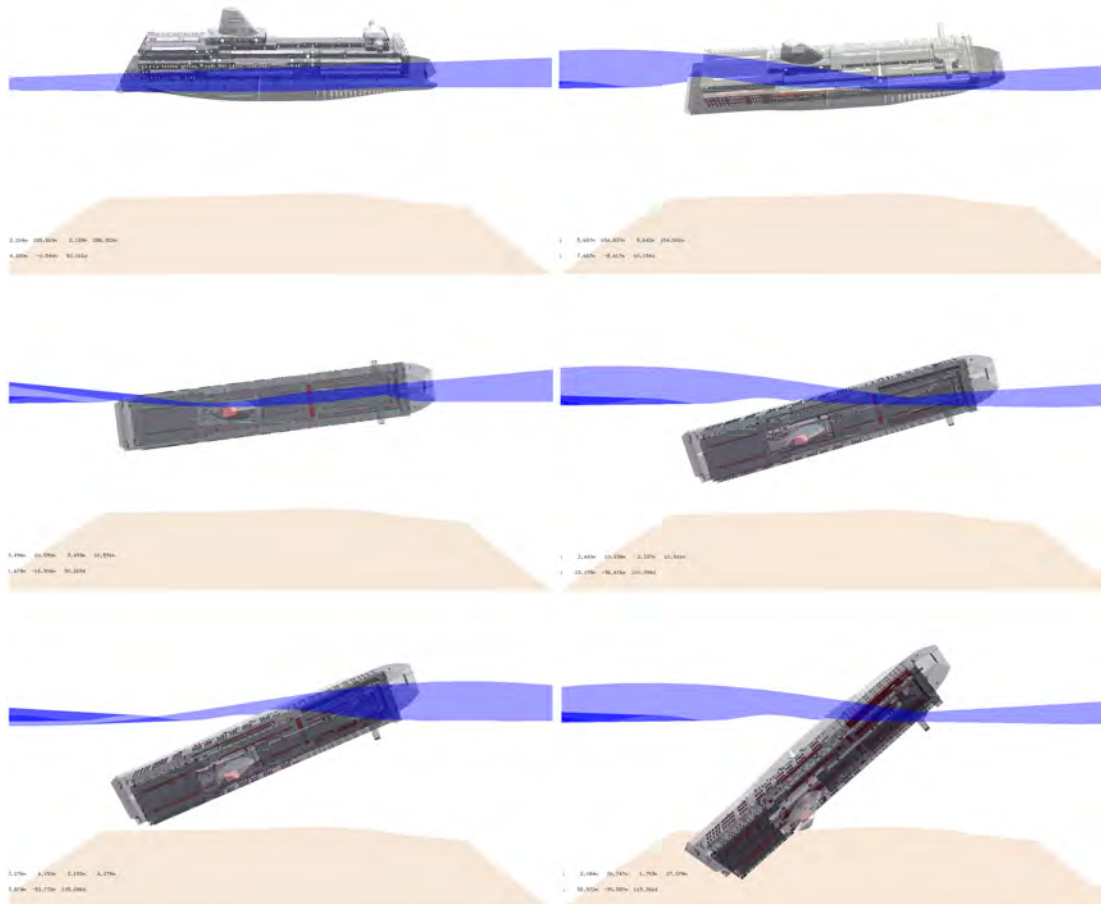
FIG. 4.9: Visualization of the numerical flooding and sinking process in the E4 program and the corresponding heel and trim development until bottom contact. Source: Hamburgische Schiffbau-Versuchsanstalt GmbH.
