# Avalanche accident in connection with heli- skiing activities near Abisko

The Swedish Accident Investigation Authority has  
investigated an avalanche accident in Kårsavagge,  
Norrbotten County, 20 March 2025

27 May 2026

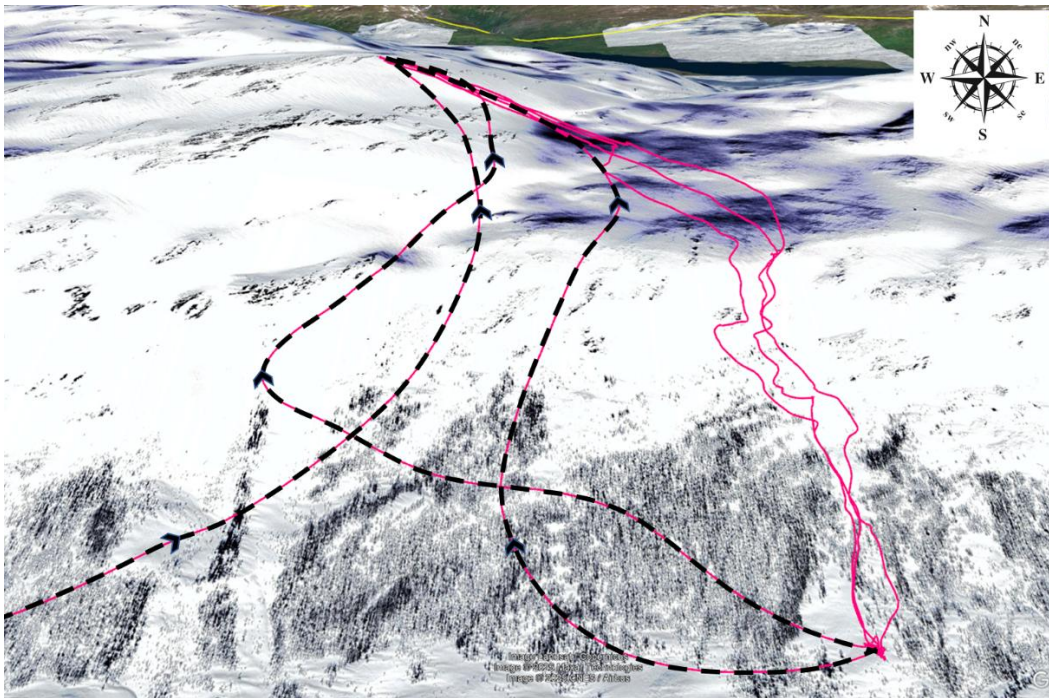
Figure 3 shows the tracks of the descents that were carried out after the lunch break, in the afternoon, prior to the accident. The figure also shows the helicopter's flight paths between the valley and the summit. The vertical drop of the runs was approximately 400 metres.

Figure 3. Satellite image of the ski area. The image includes GNSS tracks from one of the skiers from the three afternoon runs, shown as solid pink lines. The black and pink lines indicate the helicopter lifts.  
Source: Google Earth, image date 2020-04-28. Markings added by SHK.

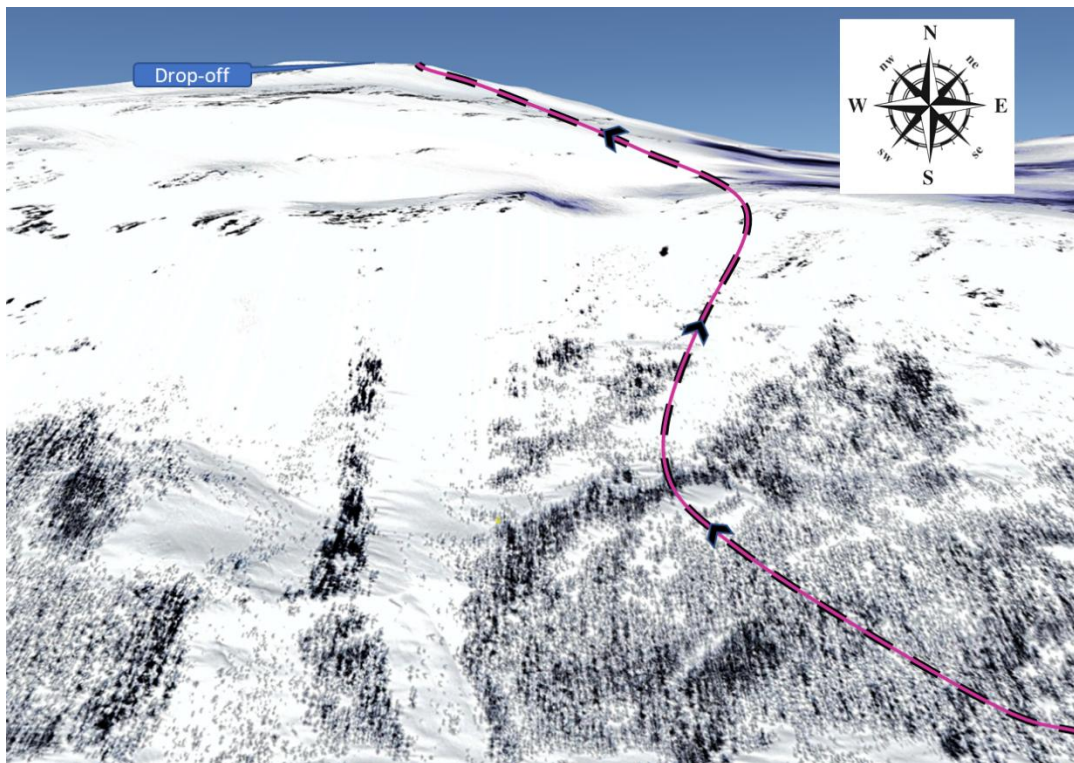
During the previous helicopter lifts, the guide carried out reconnaissance regarding possibilities for other descents westerly of the most recent runs. For the final run, a new line in this area was chosen and a more detailed reconnaissance was conducted; see figure 4. Here too, the terrain was gentle, but it bordered a steeper mountainside where larger amounts of snow had accumulated over the past few days.

Figure 4. Satellite image of the skiing area and GNSS tracks of helicopter lifts and scouting before the final run (black-pink dashed line). Source: Google Earth, image date 2020-04-28. Markings added by SHK.

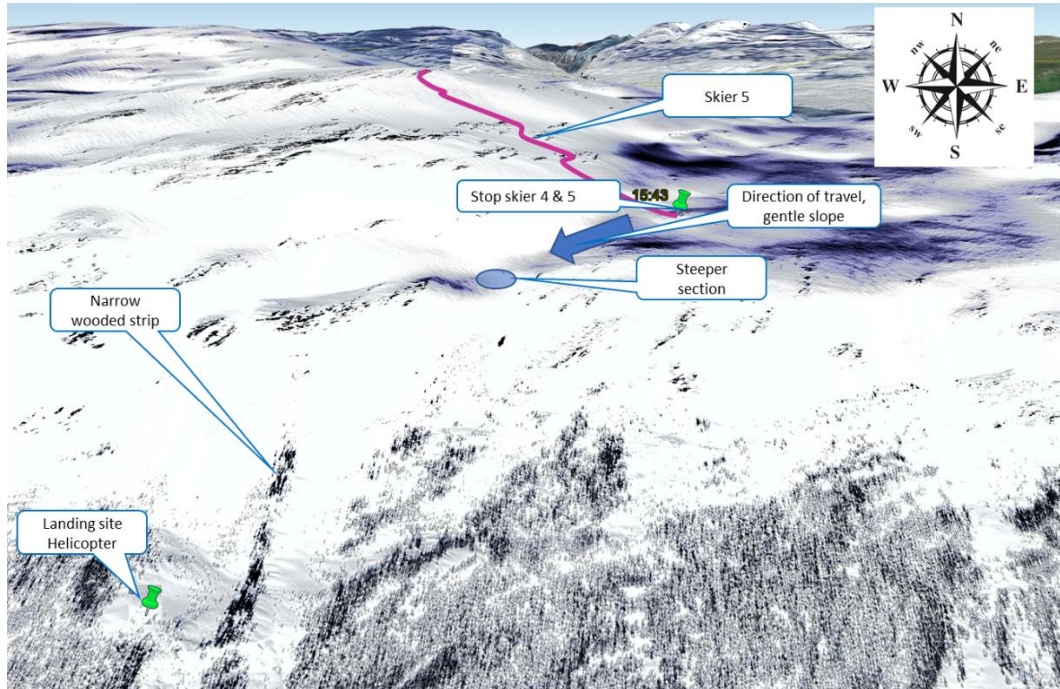
Skiers 4 and 5 lingered for a while before following the guide's tracks westward through gentle terrain towards a steeper and more convex section; see figure 6. The convex shape meant that forward visibility was impaired until the skiers reached the steep slope.

Figure 6. Satellite image of the skiing area and GNSS track from skier 5 (solid pink line). The image also shows the skiers' positions, the time of the stop, the direction of skiing and the location where the helicopter was parked. Source: Google Earth, image date 2020-04-28. Markings added by SHK.
