# Serious incident south of Örebro Airport on 11 December 2024

The Swedish Accident Investigation Authority has investigated a serious incident involving aircraft SE-LGL, a Cessna 172R, in which a loss of control occurred in connection with the use of the autopilot.

16 September 2026

File number: L-132/24

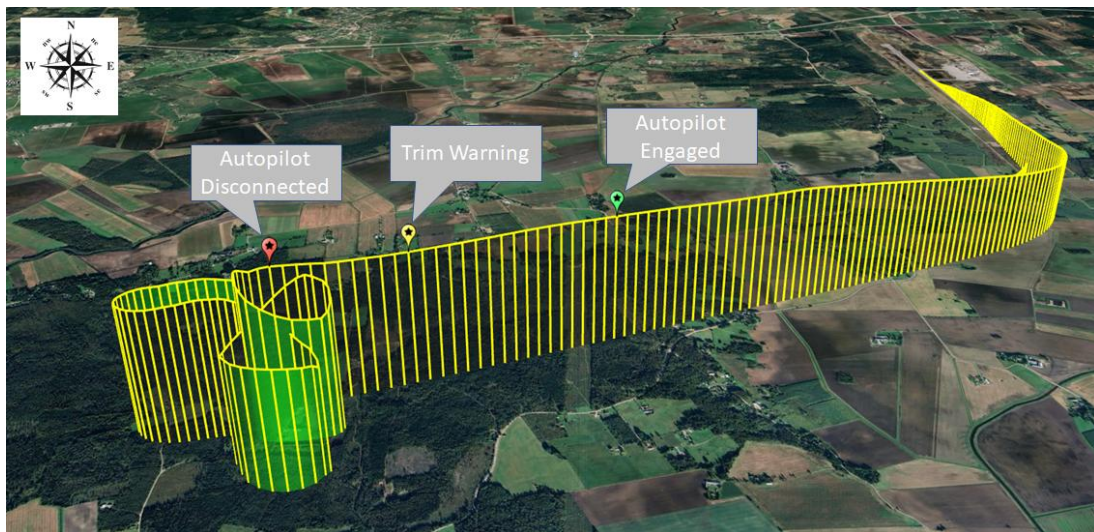
Furthermore, the video recording shows that the control yoke moved rapidly forward six seconds after the mistrim alert illuminated, at the same time as the pitch servo, according to the autopilot data, reached its maximum torque in the nose-down direction. Despite this, the rate of climb continued to increase. The video also shows that, during this period, the pilot grasped the control yoke first with his right hand and then with his left hand, and that shortly thereafter, according to the data, he disconnected the autopilot system using the switch on the control yoke, see Figure 1.

Figure 1. Flight path for the first segment of the flight. Image: Google Earth © Lantmäteriet. Markings added by the Swedish Accident Investigation Authority (SHK).
