Accident with a helicopter at Enköping/Långtora Air- port

The Swedish Accident Investigation Authority has investigated an accident with a helicopter of the model 369E with registration SE-JVM at Enköping/Långtora Airport, Uppsala County, on November 18, 2024.

13 November 2025

Final report SHK 2025:18e

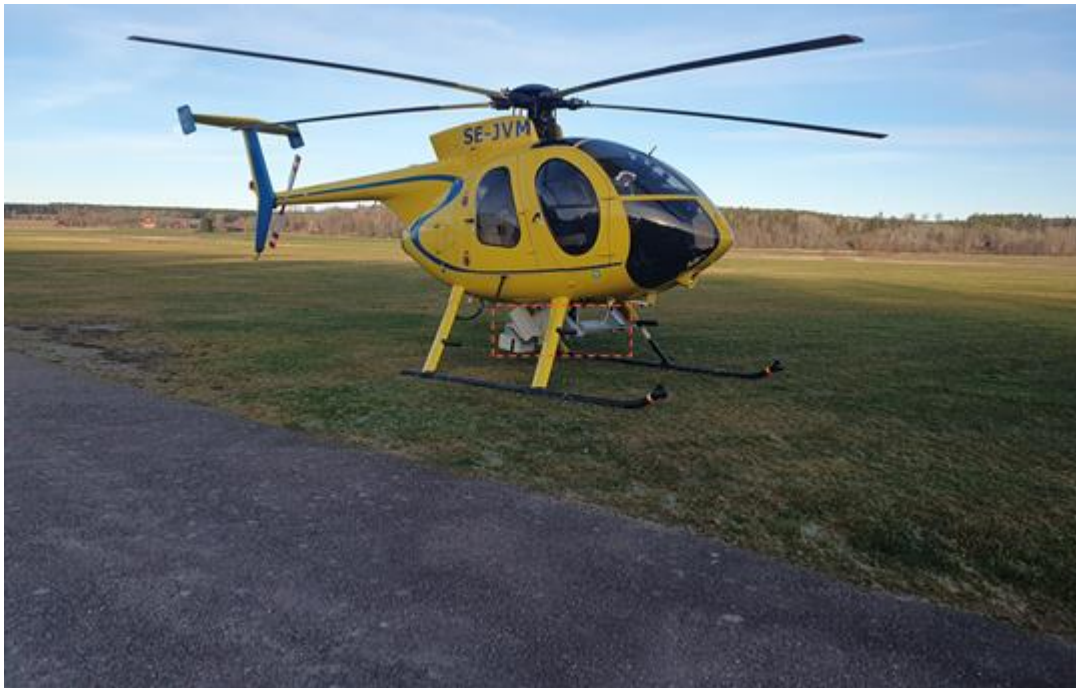
The purpose of the flight was to carry out an inspection of power lines. The flight was the second of the day and it was preceded by a refuelling stop at Enköping/Långtora Airport. The helicopter was equipped with a system that diagnoses the power lines, see Figure 1. The crew consisted of a pilot and a system operator. The pilot operated the helicopter from the seat on the left side, and the system operator was seated on the right side. The controls on the right side, where the system operator was seated, had been removed. The helicopter was parked on a grassy area outside a hangar with its nose towards the east. Before the flight, a pre-flight inspection was carried out without any remarks. The take-off weight was 2,811 lbs, according to the load chart. The weather at the location was clear and sunny, with a south-westerly wind.

Figure 1. The helicopter just before take-off. The measuring equipment is marked with a dashed rectangle. Person masked and marking added by SHK. Photo: Private person.

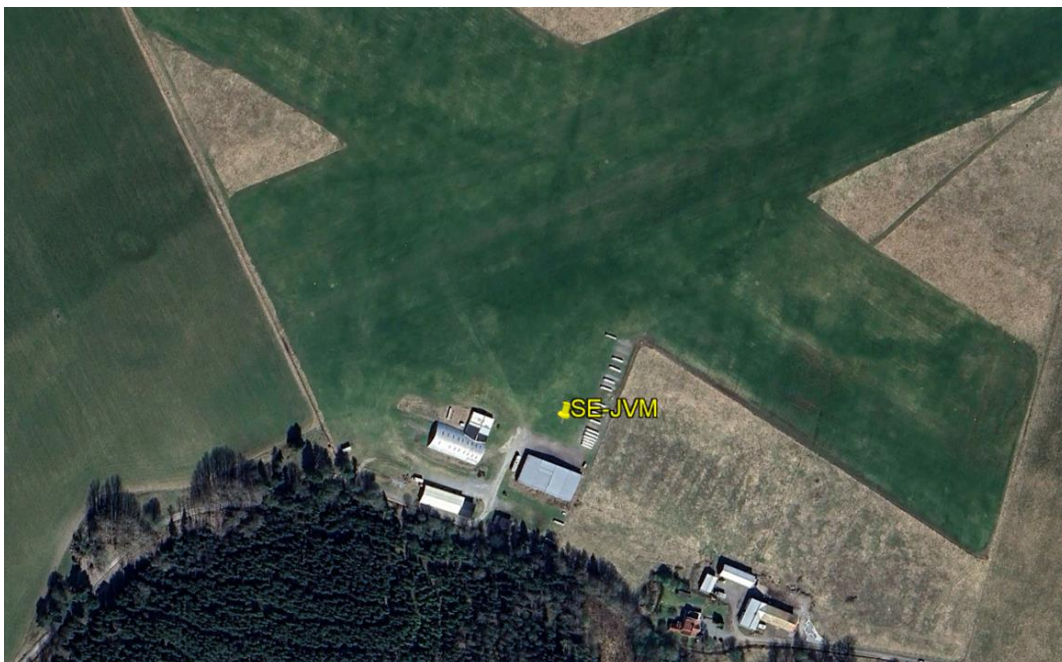
The accident occurred on a grassy area directly adjacent to an asphalt surface outside an aircraft hangar, see Figure 6.

Figure 6. Accident site marked with yellow icon. Image: Google Earth. Marking added by SHK.

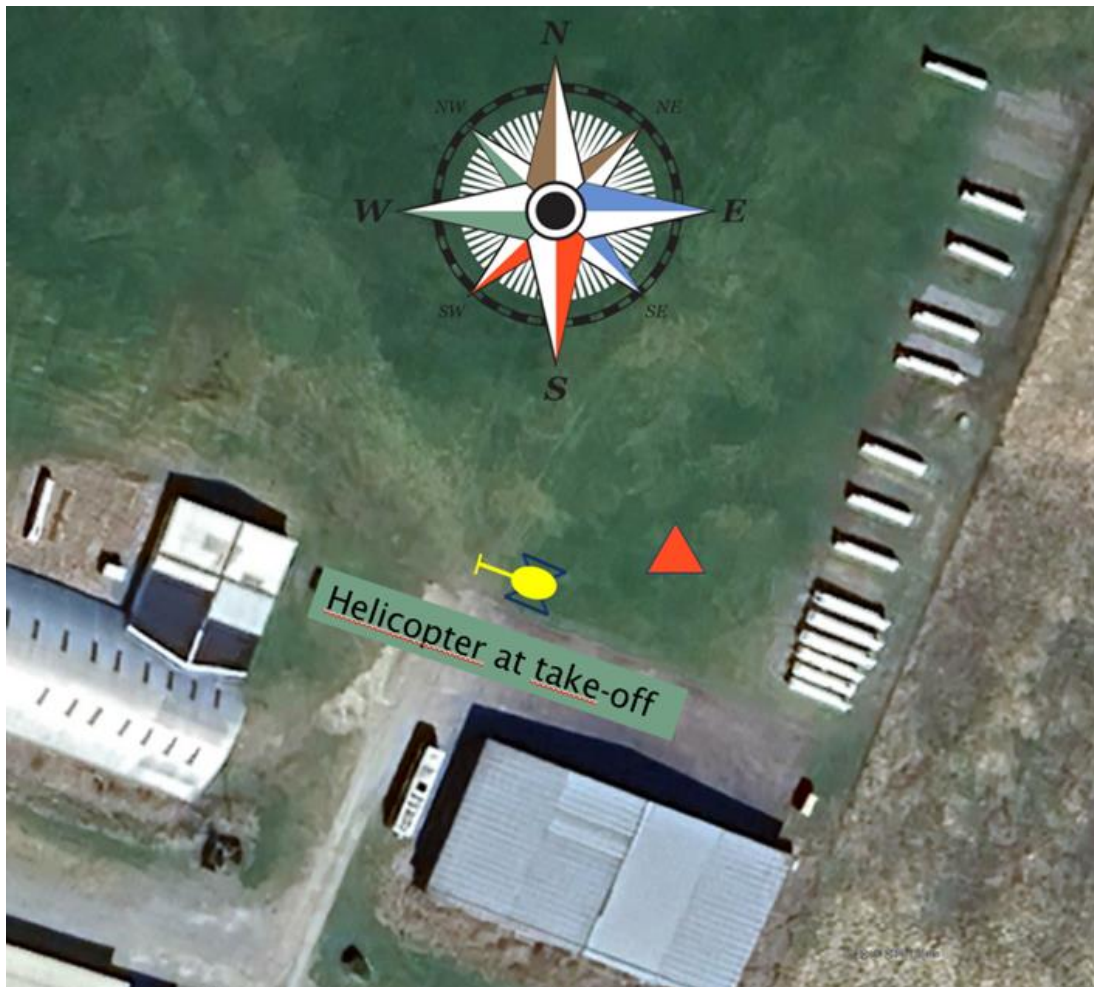
Figure 7 shows the accident site from a closer distance, with the helicopter's position and direction at take-off indicated by a helicopter icon. The impact site is marked with a triangle.

Figure 7. Principal sketch of the accident site. The helicopter's final position is marked with a red triangle. Image: Google Earth. Markings added by SHK.
