# MARCO POLO – Grounding in Northern Hanö Bay

The Swedish Accident Investigation Authority has investigated a shipping accident that took place in the northern part of Hanö Bay, Blekinge County, on 22 October 2023.

17 February 2025

File number: S-199/23

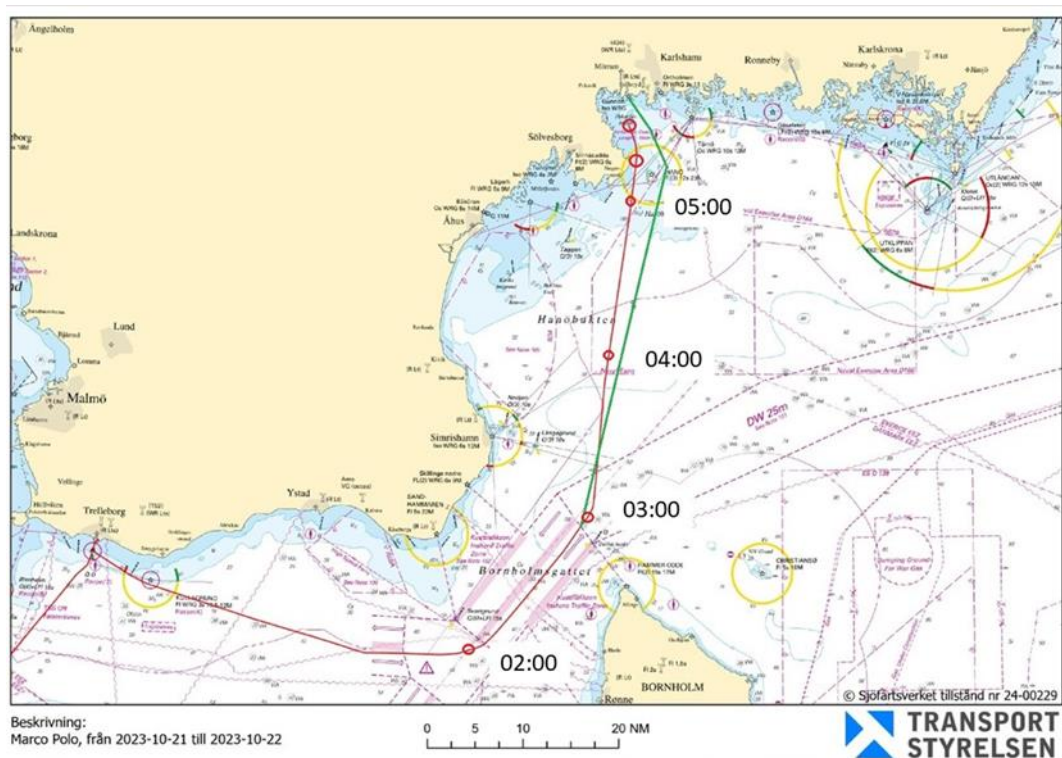
At 03:00 hrs the vessel had passed the boundary of the traffic separation scheme. After having passed another vessel on a north-easterly heading, MARCO POLO turned north to the heading 010°. According to the voyage plan the vessel was to maintain a heading of 013°. The ECDIS showed that the vessel was sailing with a drift of two degrees to starboard, i.e., that there needed to be a correction of two degrees to port. In actual fact, the vessel had a drift of two to three degrees to port. This meant that the vessel was gradually ending up further and further to the west of the planned route. The deviation between the planned route and the vessel's actual route is shown in figure 4.

Figure 4. The chart image shows the vessel's planned route in green. The red line shows the vessel's actual voyage, and the small red circles mark actual positions. The two large red circles on top of the image mark the positions of the two groundings. The image has been produced with the assistance of the Swedish Transport Agency. Chart data from © Swedish Maritime Administration licence no. 23 - 06437.

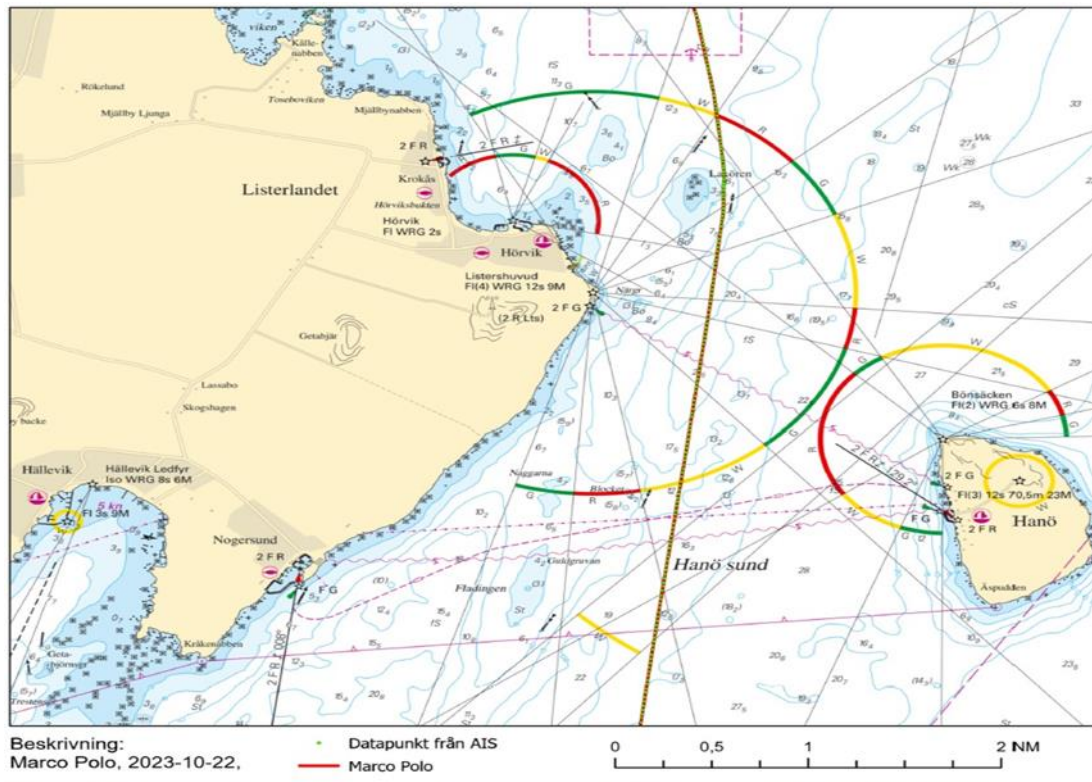
The plan was for the vessel's route to pass to the east of Hanö, with a closest point of approach of 0.8 nautical miles<sup>7</sup> east of Hanö. According to what was presented in the ECDIS-system, the vessel was proceeding along the planned route. However, the vessel was actually passing through Hanö Sound at 05:05 hrs, see figure 5.

Figure 5. The chart image shows the vessel's passage through Hanö Sound. The image has been produced with the assistance of the Swedish Transport Agency. Chart data from © Swedish Maritime Administration licence no. 24 - 06074.

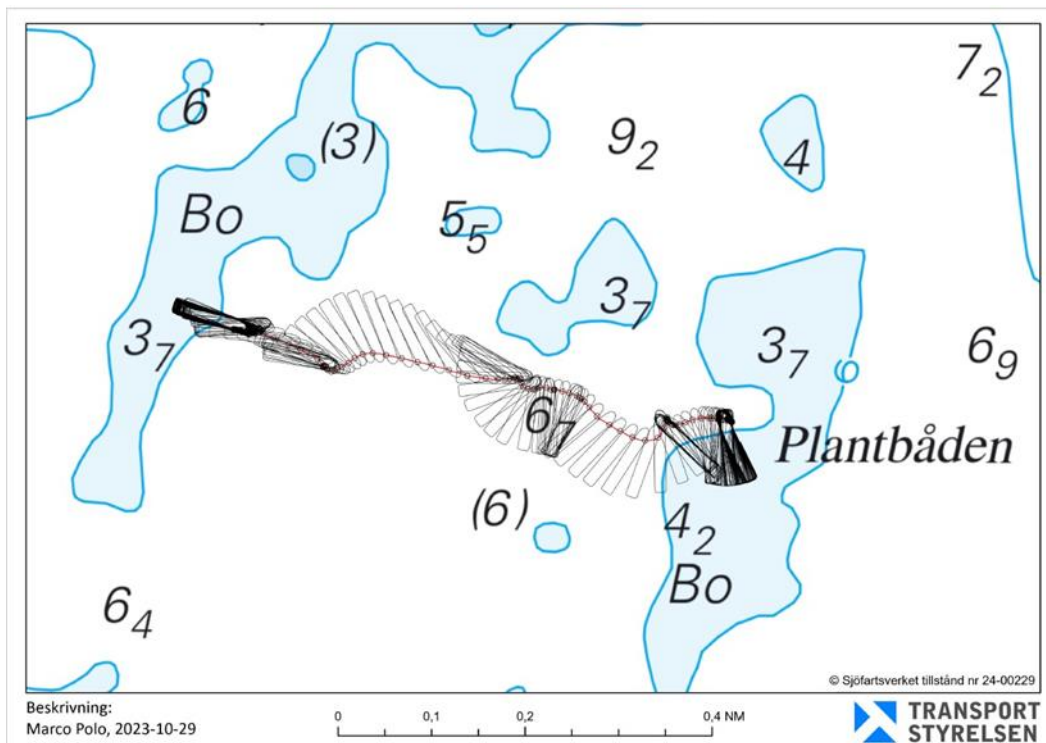
Because the vessel was subjected to wind and waves from the side, it began to turn. At around twelve o'clock the vessel slid off the shoal and began drifting in a westerly direction, see figure 8.

Figure 7. Chart showing the drifting of the vessel from the second to the third grounding location. The chart has been produced with the assistance of the Swedish Transport Agency.
