Engine failure involving Saab 340B, VH-RXE

140 km south of Perth, Western Australia on 21 December 2022

Aviation Occurrence Investigation (Short)

AO-2022-066

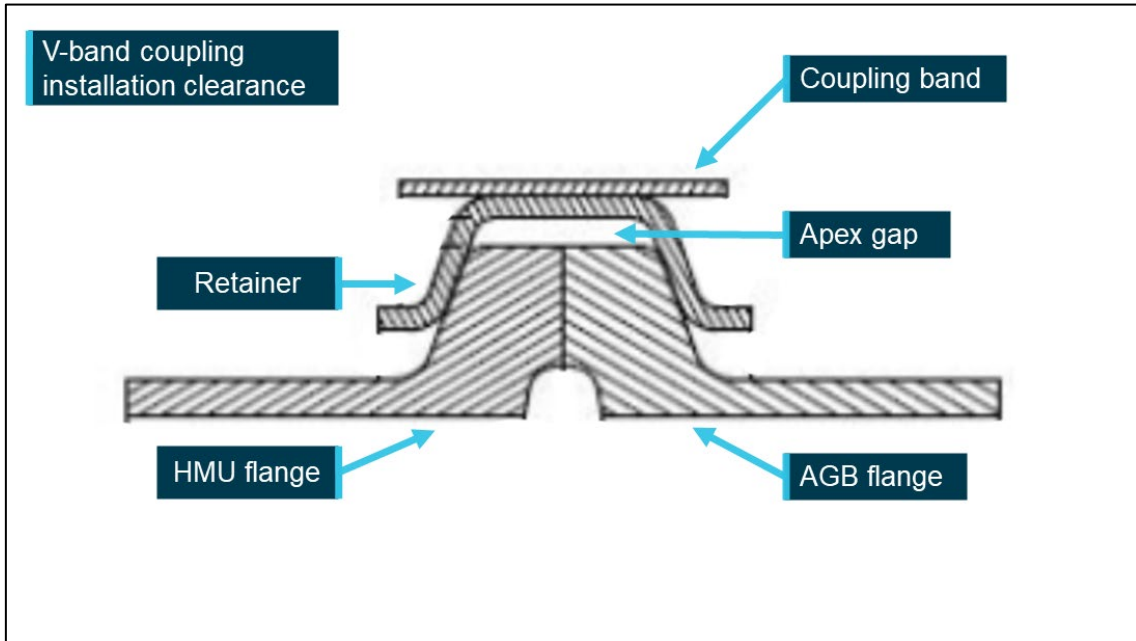
Figure 3: V-band coupling clearance after installation

The HMU is secured to the AGB by a V-band coupling (Figure 2). A V-band coupling consists of a series of V-shaped retainers that are welded to a band, these retainers fit over flanges on the HMU and the AGB. A single nut tightens the band which evenly distributes pressure around the entire circumference of the flanges holding them together. If the coupling is correctly aligned on the flanges, the inner diameter of the band maintains a clearance, known as the apex gap, to the AGB and HMU flanges with flange contact only on the sides of the V-band retainers (Figure 3).

The incorrect alignment or incorrect seating of an aircraft or engine component may not be readily apparent after the installation of a V-band coupling or clamp. Personnel installing V-band couplings are reminded to ensure the correct seating and alignment of flanges and the V-band coupling prior to the fitment and torquing of attaching hardware. The incorrect alignment of a component may induce a fault and subsequent failure of a critical component after an extended period of operation.
