ROV VIDEO SURVEY OF THE SELECTED SONAR TARGETS ON THE SINKING TRACK OF MV ESTONIA ON THE BALTIC SEA JULY 1 TO JULY 4, 2024

PRELIMINARY ASSESSMENT
FACTUAL REPORT
OCCURENCE ID: M280994

Document ID: OJK-M280994-FaR-240704-R00-EN
Document version: Revision 0
Document date: 2024-09-03

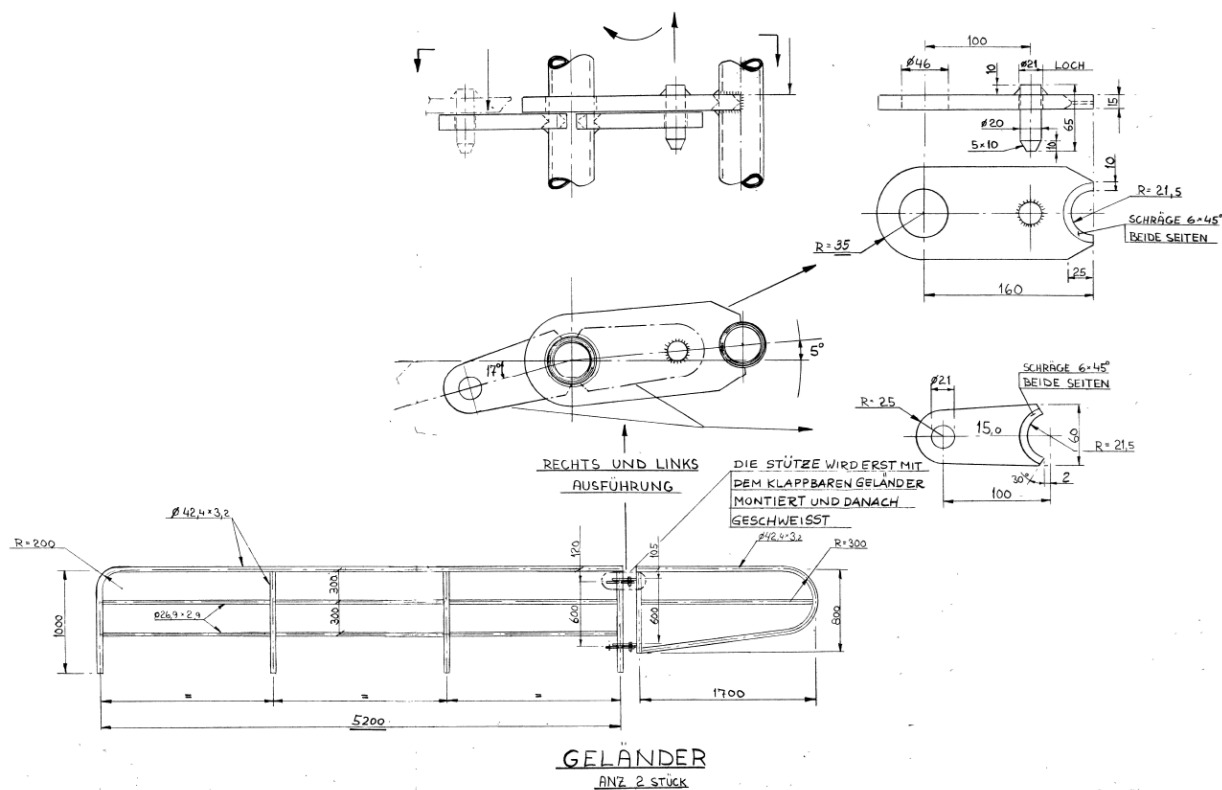
Figure 8. Original shipyard drawing of the ramp railings illustrating the rotatable part of the railing and the locking lugs and pins. VonTell drawing No 49111-302 'Details für Bugrampe'.

Further analysis showed that this item originates from the starboard side railing arrangement (Figure 7). Ramp railing arrangement was longitudinally symmetrical, but the lugs of the locking pins of the rotatable parts were aligned outwards. Comparing these details of the recovered part with the shipyard drawing made it possible to conclude from which side the object originates.
