# Fire at Liseberg Oceana Waterworld in Gothenburg

The Swedish Accident Investigation Authority has investigated a fire at the construction work site Liseberg Oceana Waterworld in Gothenburg, Västra Götaland County on 12 February 2024

20 March 2025

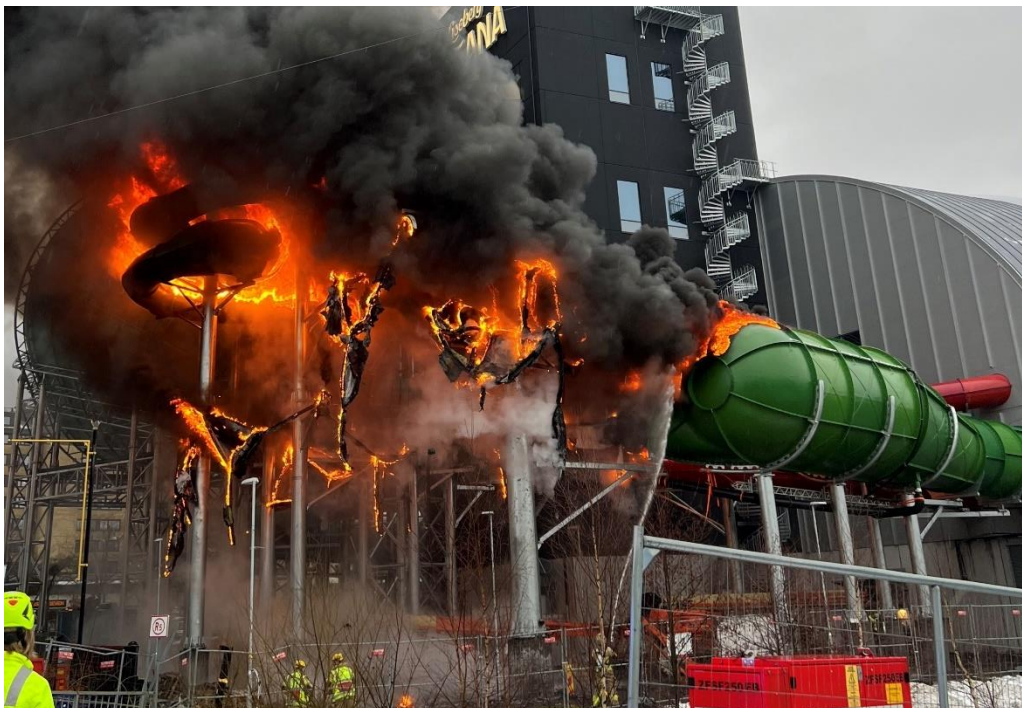
Figure 8. Firefighting taking place. Photo from 10:16 hrs. Photo: EnviroProcess Sweden AB.

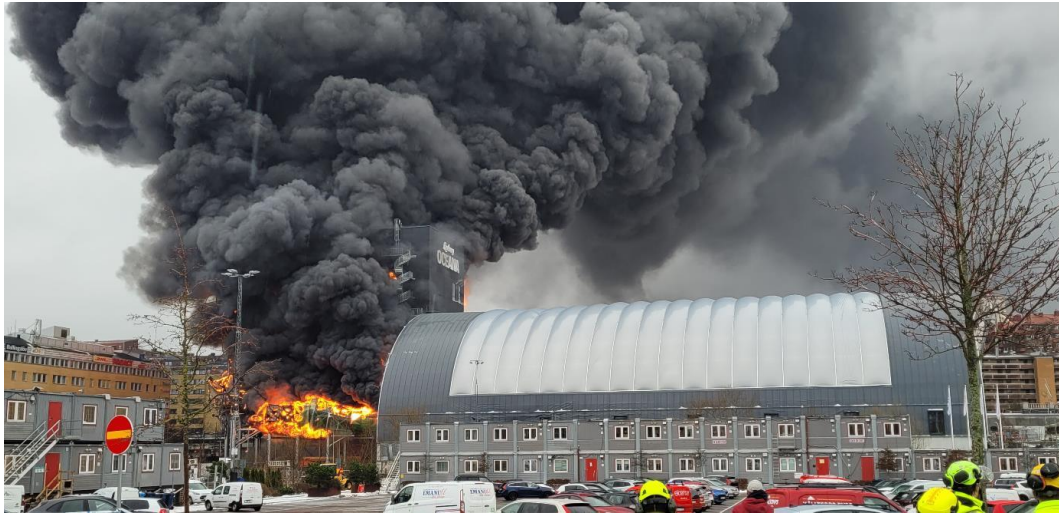
The heavy smoke development meant that thick smoke was spread by the wind over a large area (see Figure 10). The fire and rescue service therefore decided to issue a VMA<sup>1</sup> to stay indoors and close the ventilation. The VMA was active from 10:50 to 19:55 hrs. The smoke had an impact on, e.g. Sahlgrenska Hospital, which had to close its fresh-air intake.

Figure 10. The smoke had an impact on, among other things, Sahlgrenska Hospital. Photo: EnviroProcess Sweden AB.

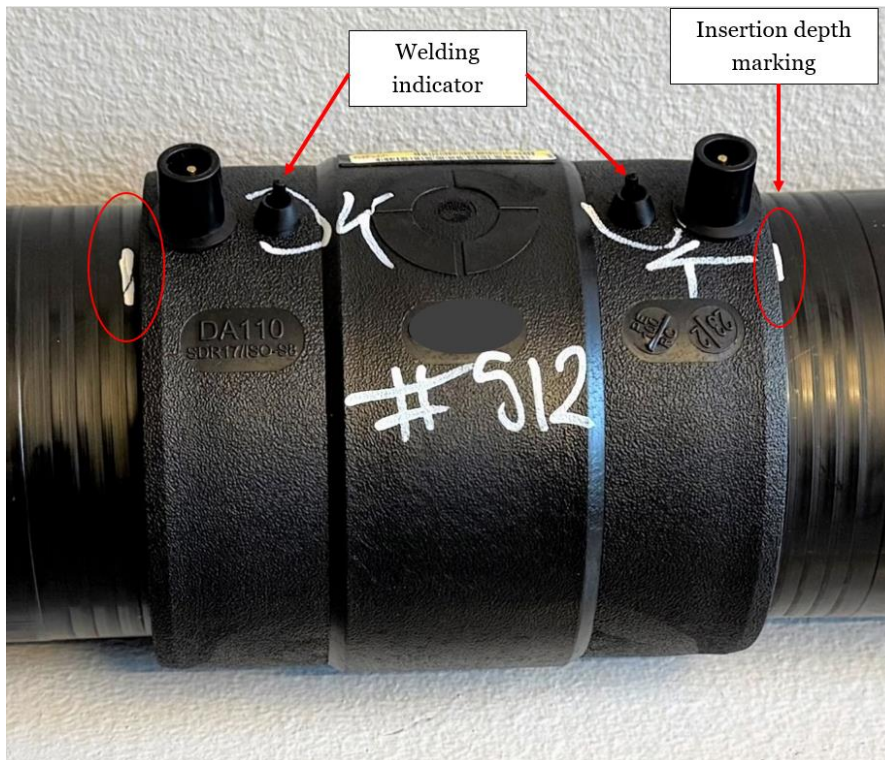
The guidelines state that, in order to ensure that the distance between the ends of the pipes is correct and that the pipes are placed in the middle of the electrofusion coupler, the insertion depth should be measured and marked on the pipes. Examples of how marking is to be done are shown in Figure 13.

Figure 13. Example showing markings of insertion depth. The weld indicators that indicate that the material has melted in the weld joint is also shown in the picture.

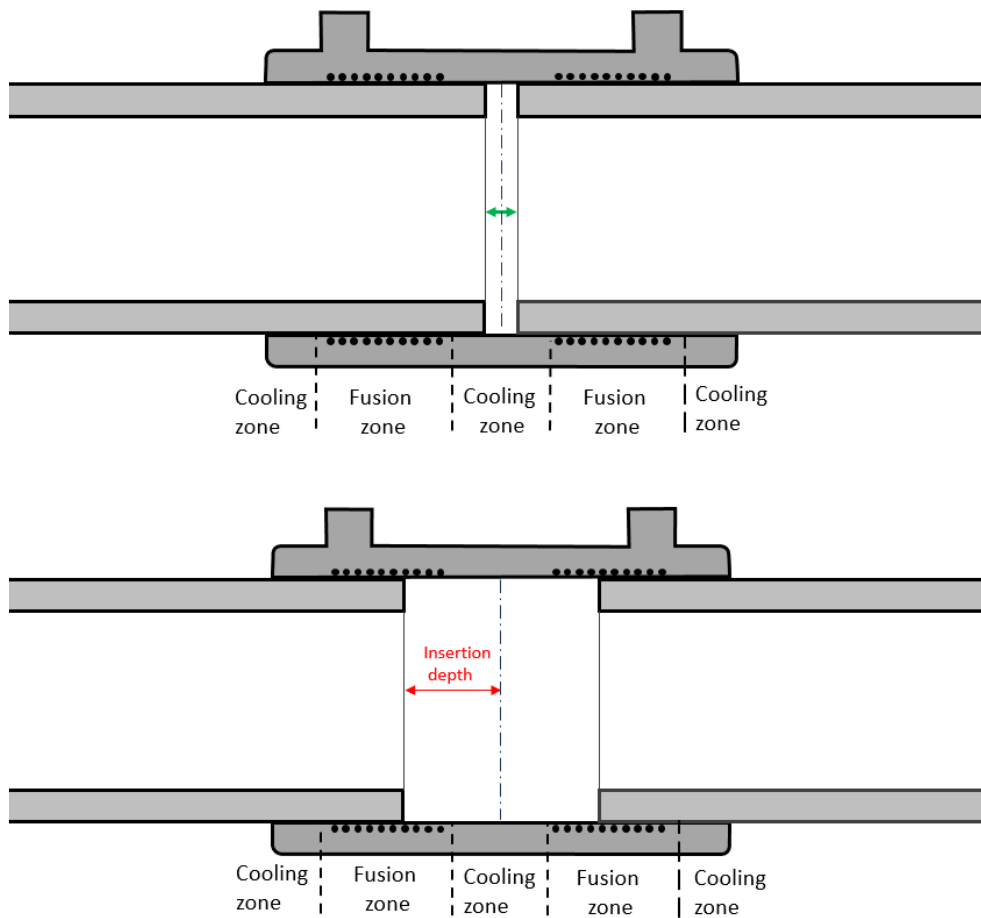
During electrofusion the whole electrofusion coupler is not heated, rather there are fusion zones and cool zones<sup>11</sup>. In the fusion zone the temperature rises to between 230°C and 250°C, which makes the plastic material in the coupler and the pipe melt together (see Figure 14).

Figure 14. The sketch above shows a correctly fitted electrofusion coupler where the ends of the two pipes that are to be joined are in the inner cool zone. The green arrow shows the maximum permitted distance between the ends of the pipes. The red arrow in the lower sketch shows an incorrect insertion depth. The ends of the pipes lie in the fusion zones and metal wires are exposed without meeting pipe material. Source: GPA Flowsystem AB. Markings made by SHK.

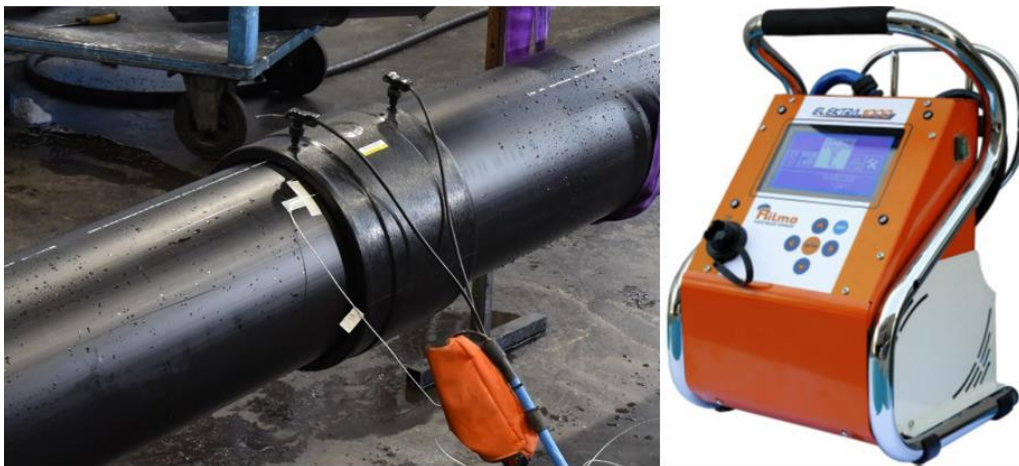
The tests were performed using the same type of electrofusion machine, pipe and electrofusion coupler used in the work with the diversion pipes under Rattler. The dimension of the pipes was 315 mm<sup>13</sup> and they weighed 17.6 kg per metre. The electrofusion coupler<sup>14</sup> was from AGRU and had a weight of 6.36 kg (see Figure 15).

Figure 15. The picture on the left was taken in conjunction with SHK's fire tests and shows a fitted electrofusion coupler with connected power cables. The picture on the right shows an electrofusion machine of the type Ritmo Elektra 500. Source: GPA Flowsystem AB.

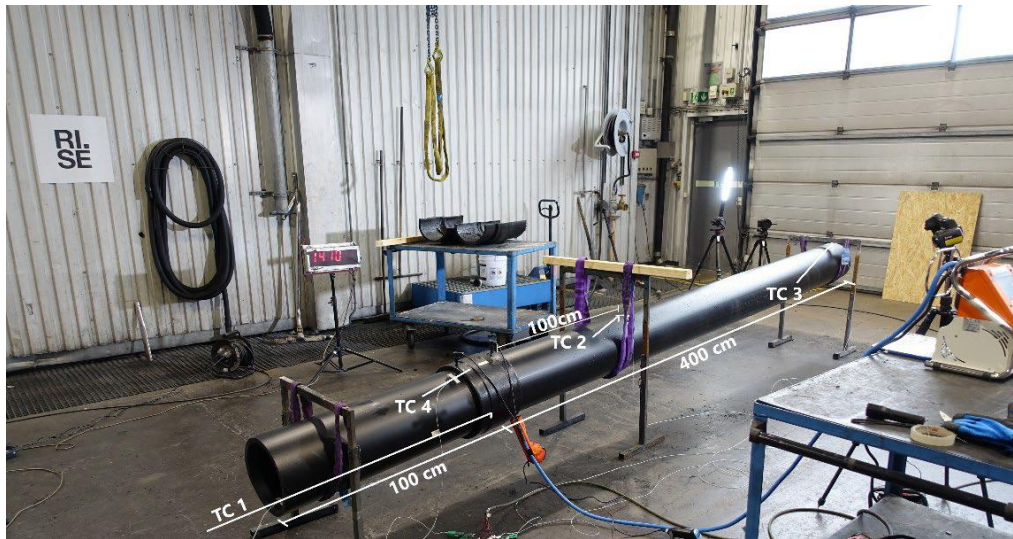
Each test was performed with two pipes and an electrofusion coupler<sup>15</sup> that were hung up at an inclination of approximately three degrees from the horizontal plane. This was equivalent to the inclination of the pipes under Rattler during the final installation (see Figure 16).

Figure 16. The picture shows the testing arrangement of pipes with the fitted electrofusion coupler. The temperature indicator that was used to register the temperature during the tests are marked in white with the designation TC1-TC4. Source: RISE.
