## ***Interim Statement SRL 2019:01e***

**Accident near Umeå Airport,  
Västerbotten County, on the 14 July 2019  
involving the aeroplane SE-MES of the  
model GA8-TC 320, operated by Umeå  
Skydiving Club.**

File no. L-96/19

26 September 2019

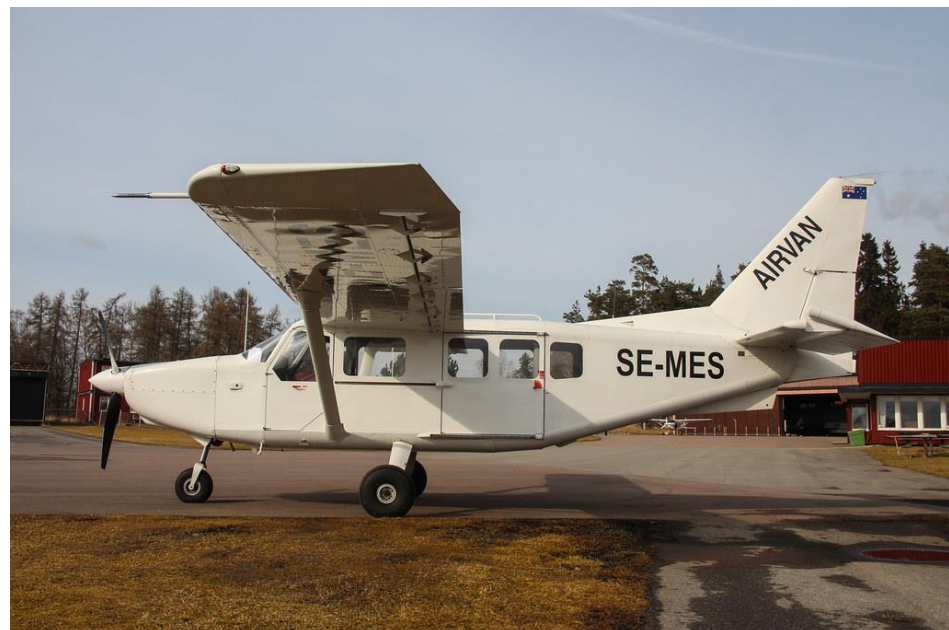
Figure 1. Aircraft SE-MES. Photo: Umeå Skydiving Club.

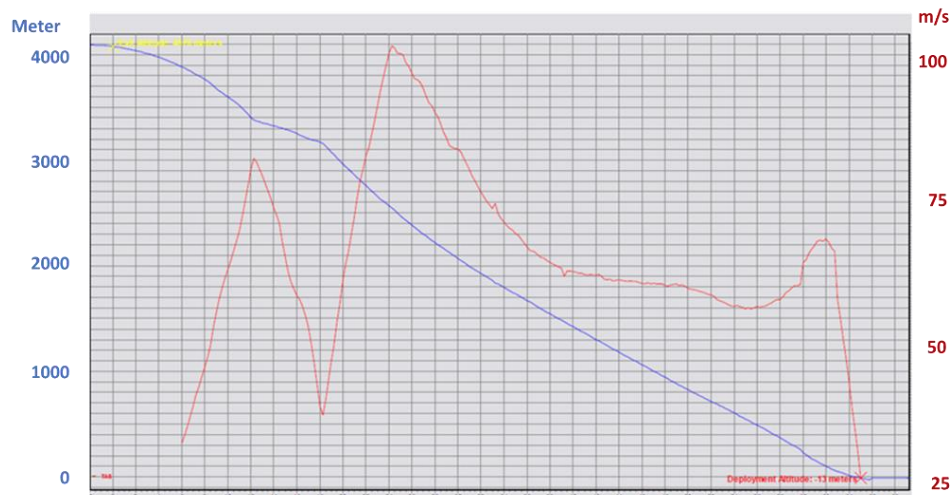
SHK has obtained data from two of the skydivers' electronic devices (ProTrack), which is intended to give the skydiver audio signals referring to altitude and descent speed. The devices have recorded altitude and descent speed. The readings have been essentially identical, and one is presented in figure 3 below.

Figure 3. The blue line shows the altitude in metres and the red line indicates descent rate in metres per second.

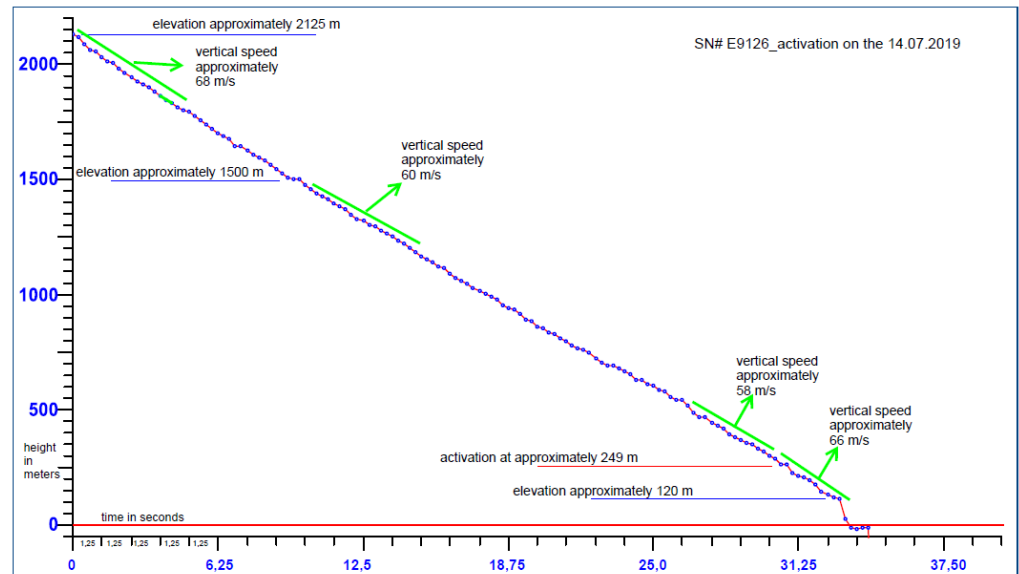
All six of the devices have recorded data from 2,200 metres down to the ground. All of them indicate the same descent rate linearly all the way, which was approximately 60 m/s (see figure 4).

All six deployed the reserve parachute as they should, depending on the selected altitude setting, at 250–350 metres above ground.

Figure 4. Reading from one of the AADs.
