# Intermediate Report of the Preliminary Assessment of MV ESTONIA

*Ohutusjuurdluse Keskus*  
*Statens haverikommission*  
*Onnettomuustutkintakeskus*

2023

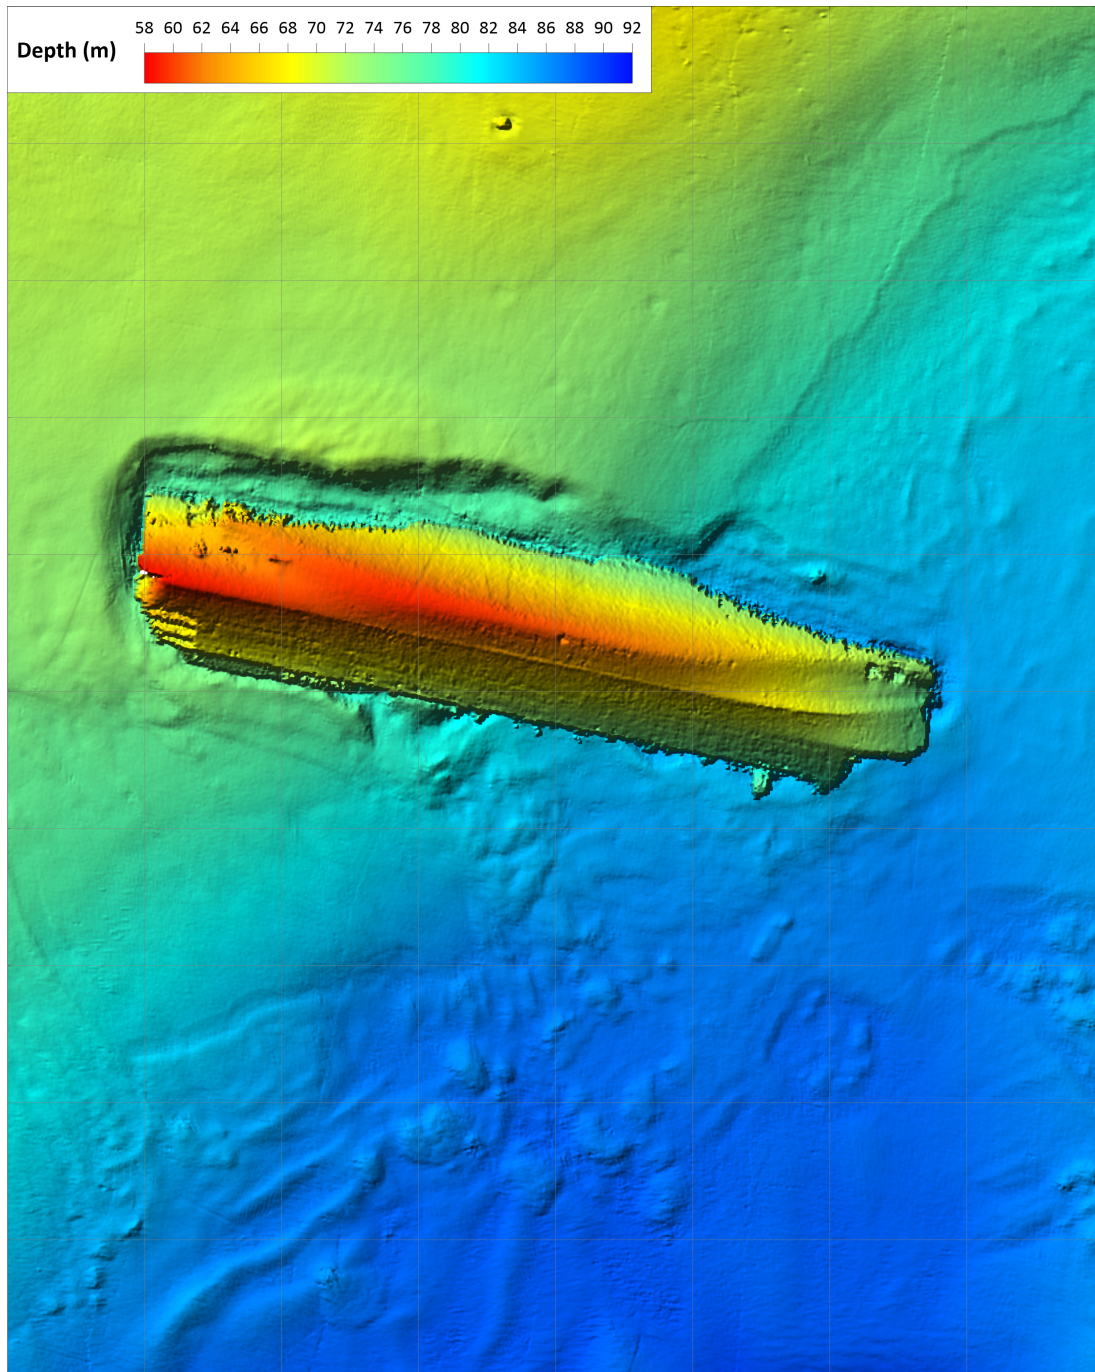
- A trench between 8 m and 1 m wide exists on the north side of the wreck.
- The ship's hull, at approximately mid-ship, seems to rest on an outcrop of bedrock.
- The bow ramp is detached from the ship and lies against the starboard side of the bow.
- The car deck seems to have a barrier of debris approximately 30 m from the entrance.

FIG. 2.2: MV ESTONIA as imaged in the 2021 MBES dataset.[3] Image by Ohutusjuurdluse Keskus.

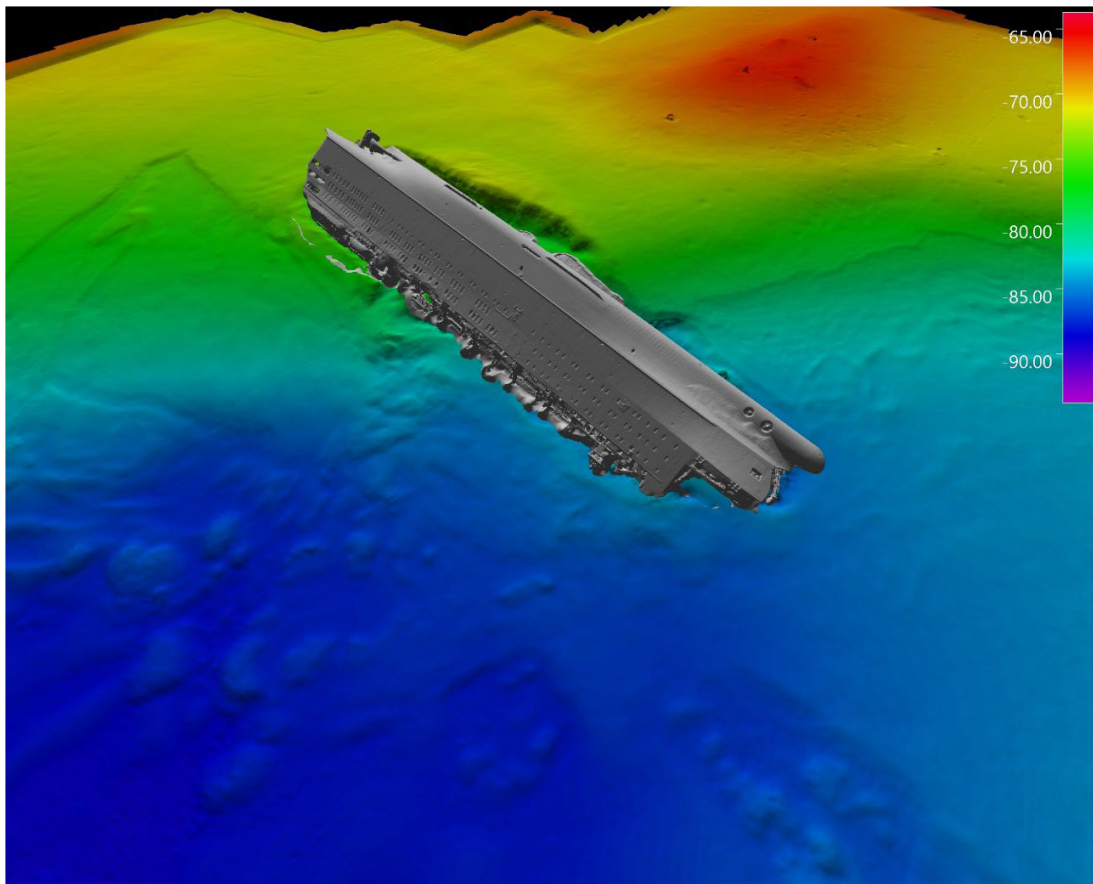
FIG. 3.1: MV ESTONIA portrayed with a mesh created at a resolution of 7 cm from the photogrammetric data; the bathymetry is represented by a 0.25 m x 0.25 m grid from the MBES survey in 2021. Visualization in QPS Fledermaus. Image by the Stockholm University.
