## CHAPTER 6

# SUMMARY OF TESTIMONIES BY SURVIVORS

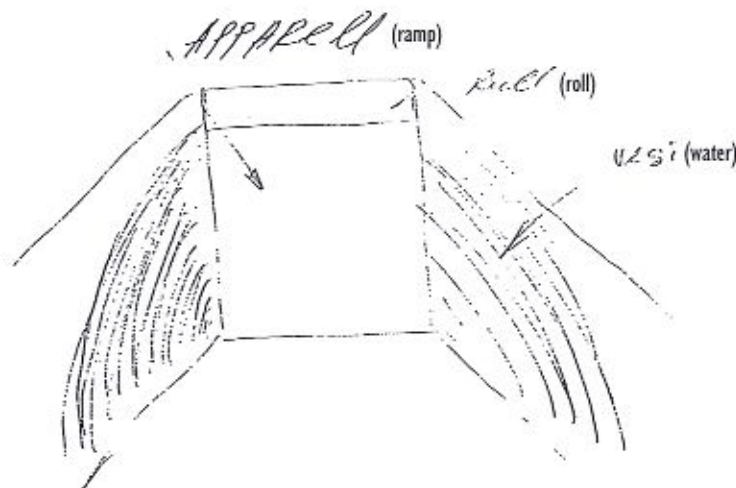
In the latest testimony [5] the system engineer made a drawing to illustrate what he saw in the surveillance monitor (Figure 6.1).

After the engines had stopped he heard the alarm *Mr Skylight to number one and two* over the public address system and soon after that the watertight doors were closed and the boat alarm sounded. He asked the third engineer what was going on and why the water was coming in, which he was able to see on the monitor, but got no reply [4]. Later in this testimony he clarified that he did not observe any water entering the car deck, only that the third engineer told him about it.

Figure 6.1 Drawing made by the system engineer showing what he saw in the surveillance monitor.

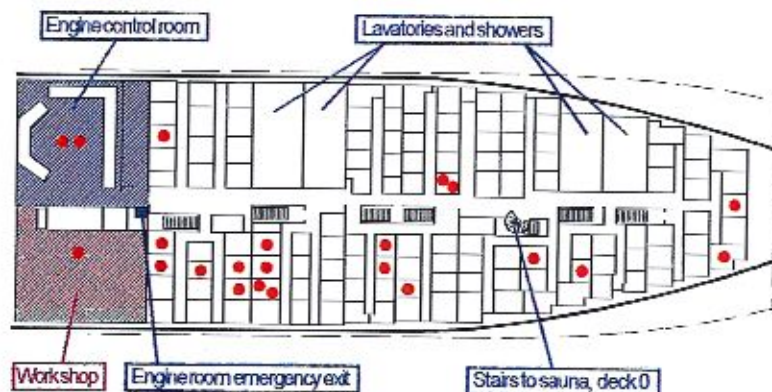
From this deck there were 22 survivors. Three of them were crew members from the engine room and 19 were passengers from the cabin area. Figure 6.2 shows the engine area and the cabin department with all known locations of survivors.

Figure 6.2 Plan showing deck 1. Red dots mark all known locations of survivors at the onset of the accident.

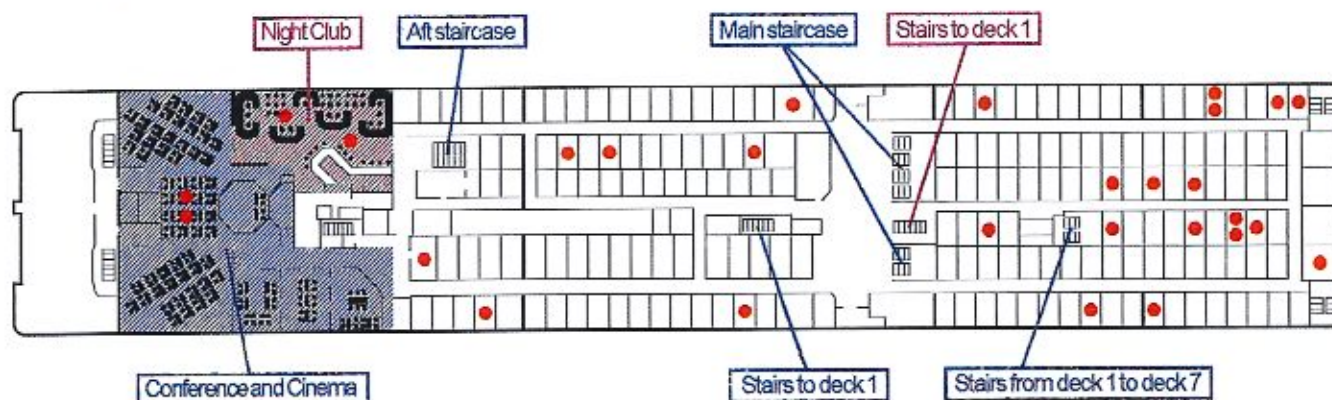
Figure 6.3. Plan showing deck 4. Red dots mark all known locations of survivors at the onset of the accident.

From deck 4, 32 people survived. Most remembered their cabin numbers. Probably seventeen escaped from the forward cabin area and six from the midship cabin area, two from the Night Club, one from the lavatory close to the conference area and two from the cinema in the conference area. Four survivors from this deck cannot remember their cabin numbers. Figure 6.3 shows the plan of deck 4 and the locations of survivors.

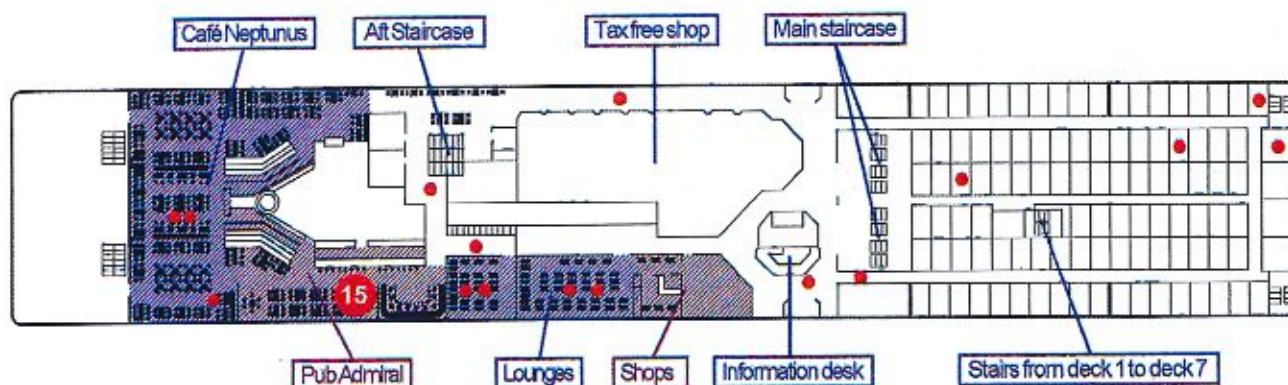
were on different locations in the arcade and hall close to the shops and the information desk. Fifteen were in the Pub Admiral, three in the Café Neptune and four in the lounges. Figure 6.4 shows the plan of deck 5 and the locations of survivors. Photos in Figures 6.5 and 6.6 show Café Neptune and the aft staircase on deck 5, respectively.

Figure 6.4 Plan showing deck 5. Red dots mark all known locations of survivors at the onset of the accident. Digits in red dot refer to numbers of survivors from this area.

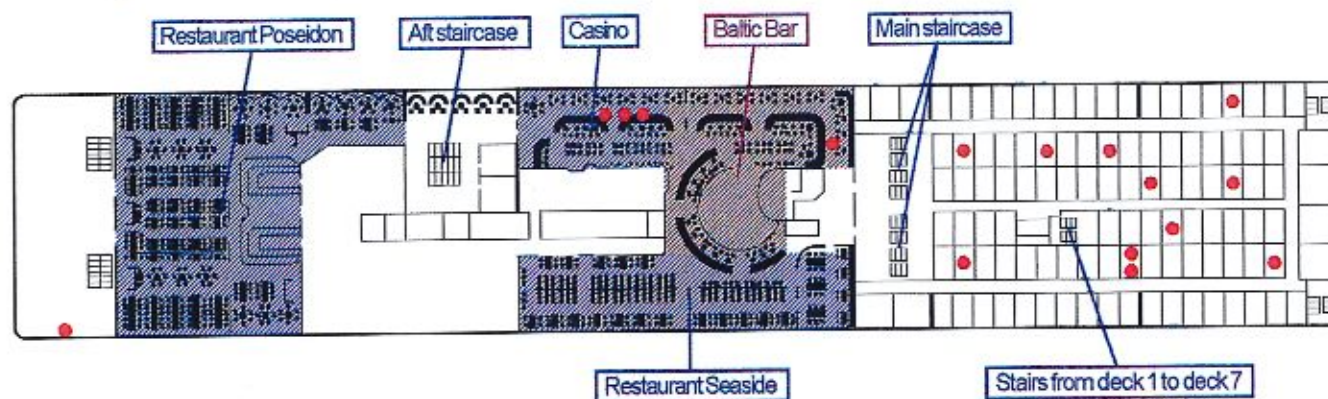
From deck 6, sixteen people survived. At the time of the accident eleven survivors were in their cabins, one in the Baltic Bar, three in the casino and one out on the aft deck. Figure 6.7 shows the plan of deck 6 and the locations of the survivors.

Figure 6.7 Plan showing deck 6. Red dots mark all known locations of survivors at the onset of the accident.

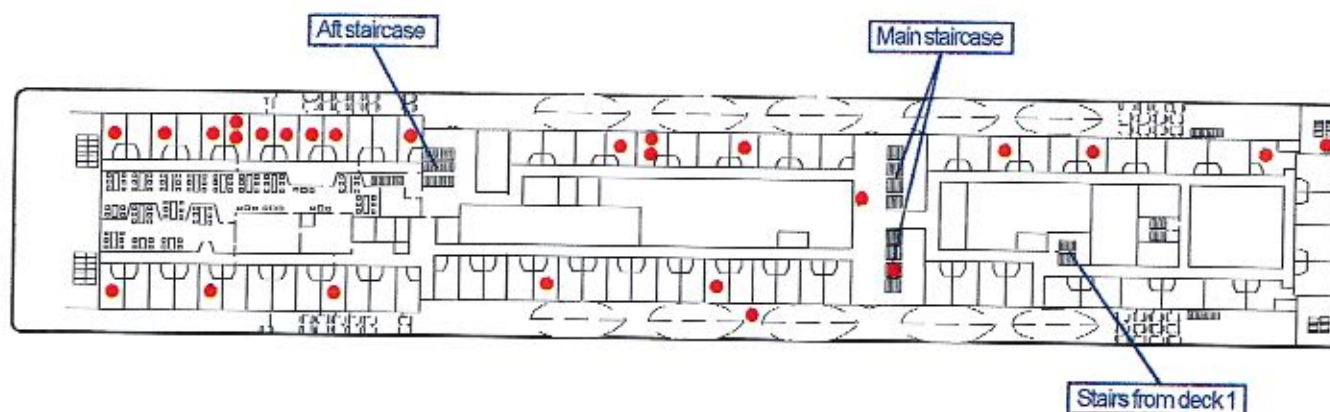
From deck 7, 26 people were rescued, most of them crew members and entertainers but also two passengers. Twenty-two were in cabins, one out on starboard deck, one in the hall near the main staircase. One was in the main staircase between deck 6 and 7 and one in the forward port staircase. Figure 6.8 shows the plan of deck 7 and the locations of survivors.

Figure 6.8 Plan showing deck 7. Red dots mark all known locations of survivors at the onset of the accident

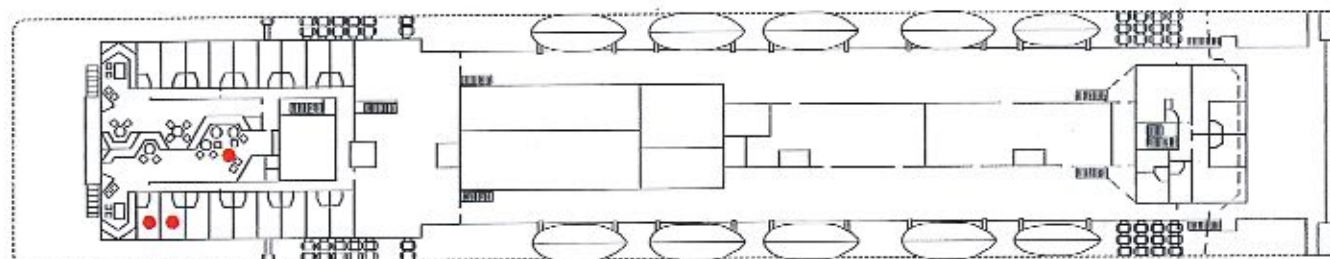
From deck 8 four crew members survived. Two of them were in cabins, one in the messroom and one was in an undecided port cabin. Figure 6.9 shows the plan of deck 8 and the known locations of survivors.

Figure 6.9 Plan showing deck 8. Red dots mark all known locations of survivors at the onset of the accident.

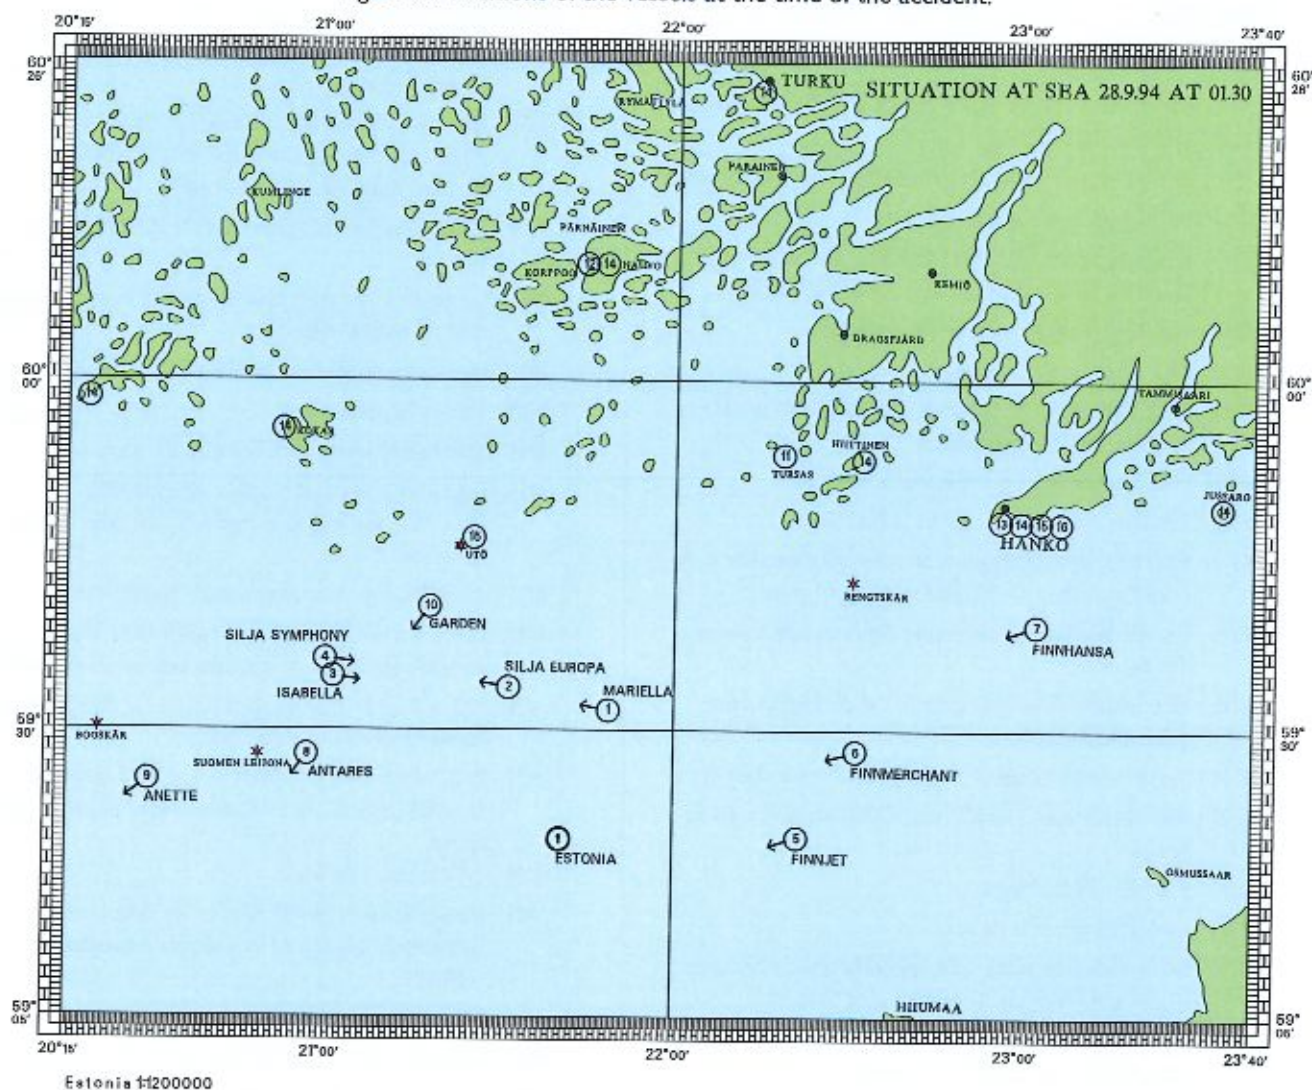
Figure 7.1 Positions of the vessels at the time of the accident.

Figure 7.1 shows the positions of the vessels at about the time of the accident.

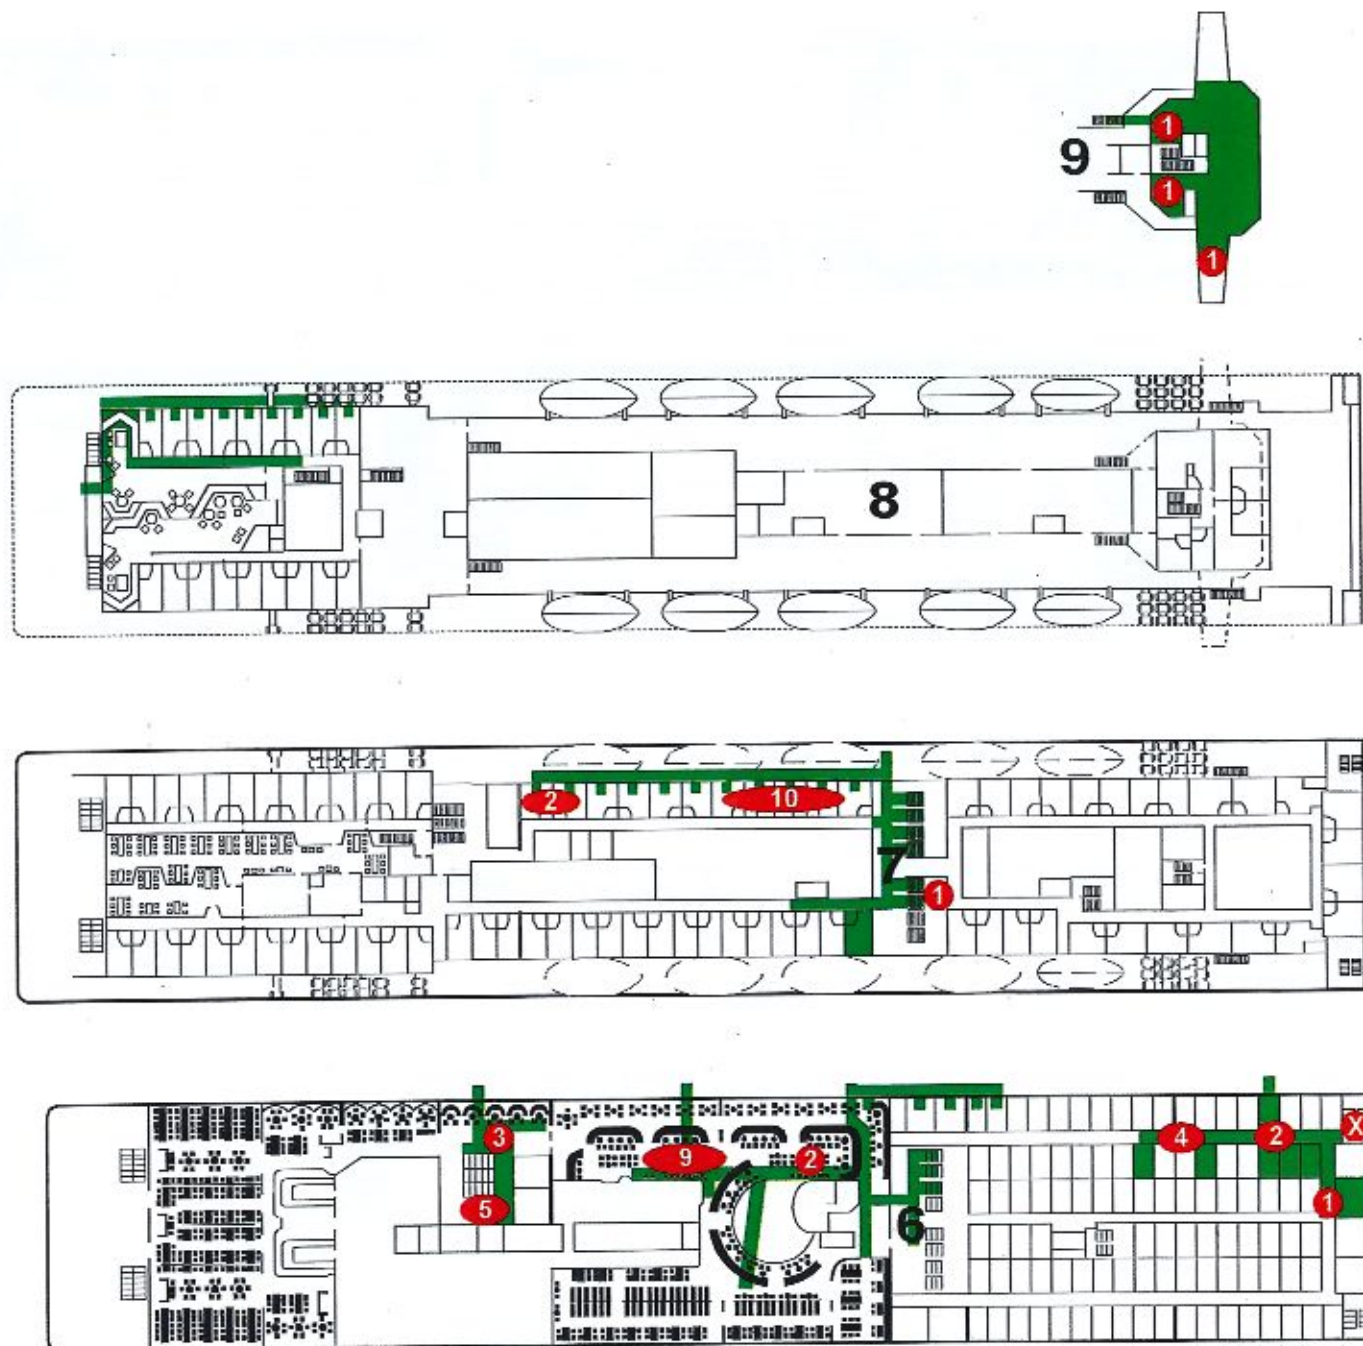
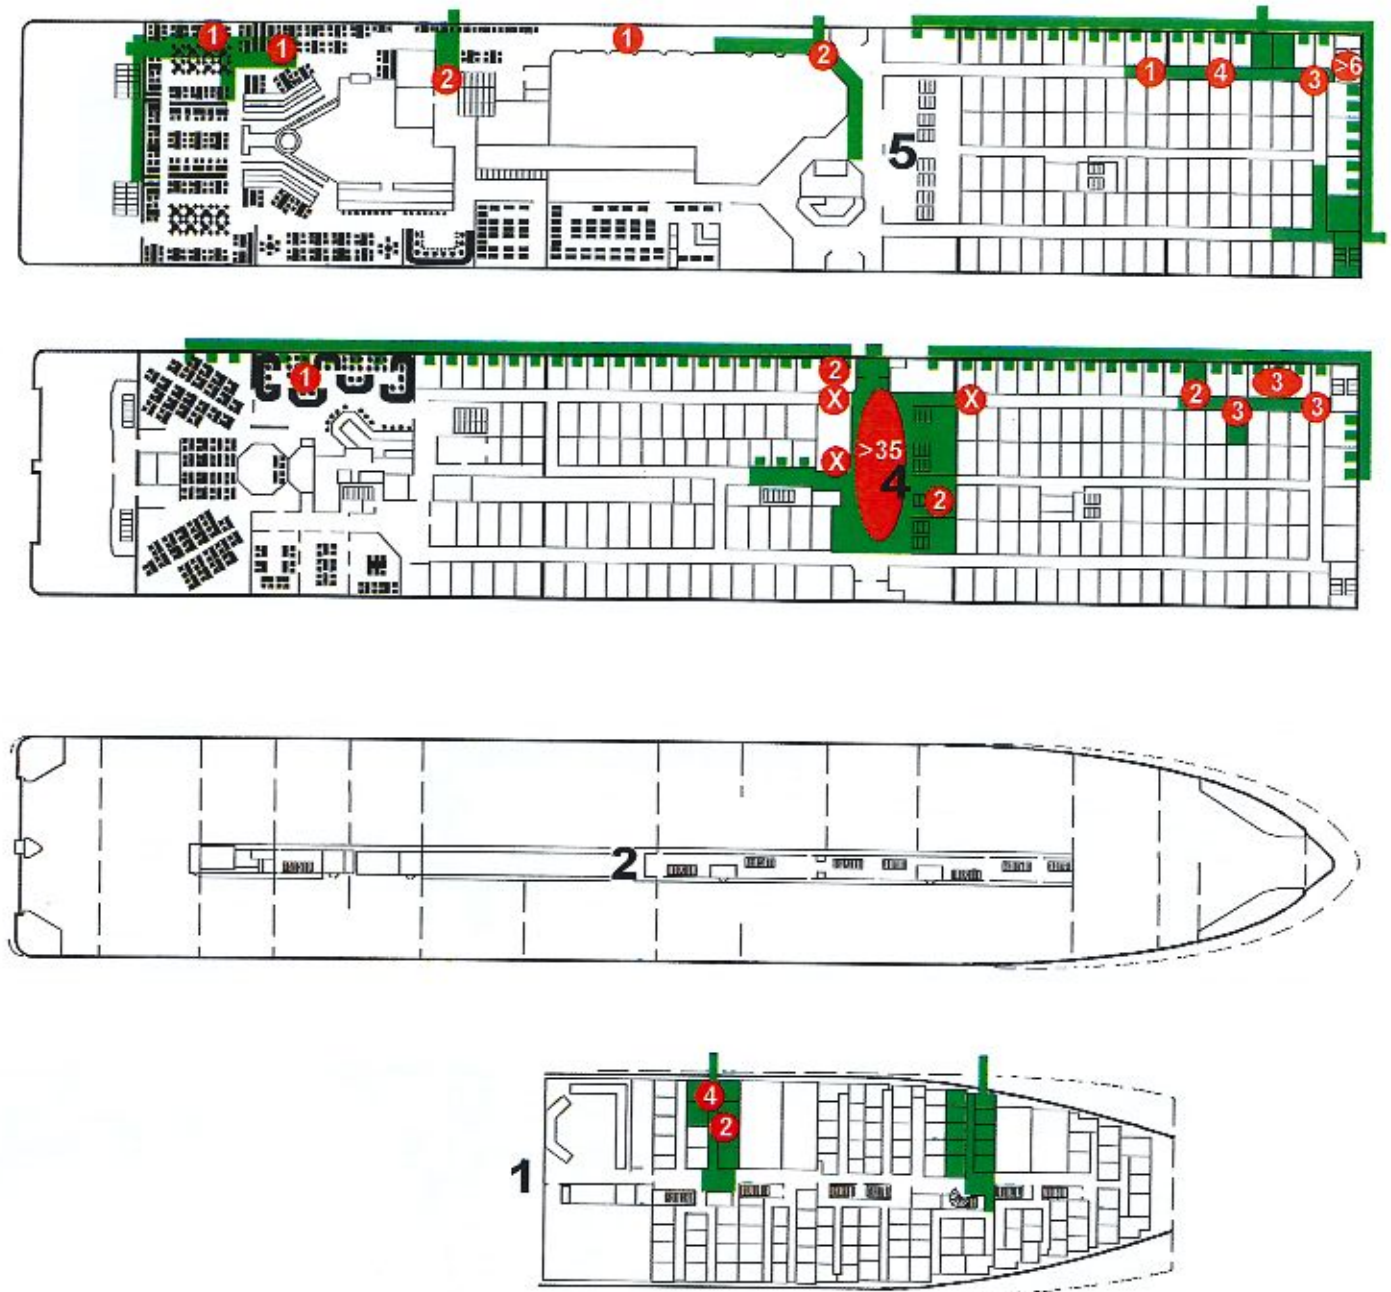
Figure 8.27 Divers' sightings of victims.

The survey of the interior was only partial and essentially limited to public areas and cabins along the port side of the wreck. About 130 victims, including those on the bridge, were observed in different areas. Many victims in various localities had lifejackets on. The parts of the ship inspected by the divers and the locations where victims were seen are shown in Figure 8.27.

Green colours indicates divers' movements and inspection of interior from outside through windows and from inside. Red circles and ovals show approximate locations where victims were sighted. White figures indicate numbers of victims at each location. White 'X's indicate unspecified numbers of victims, e.g. where doorways were blocked, preventing divers from entering.
