## CHAPTER 16

# ANALYSIS OF THE EVACUATION

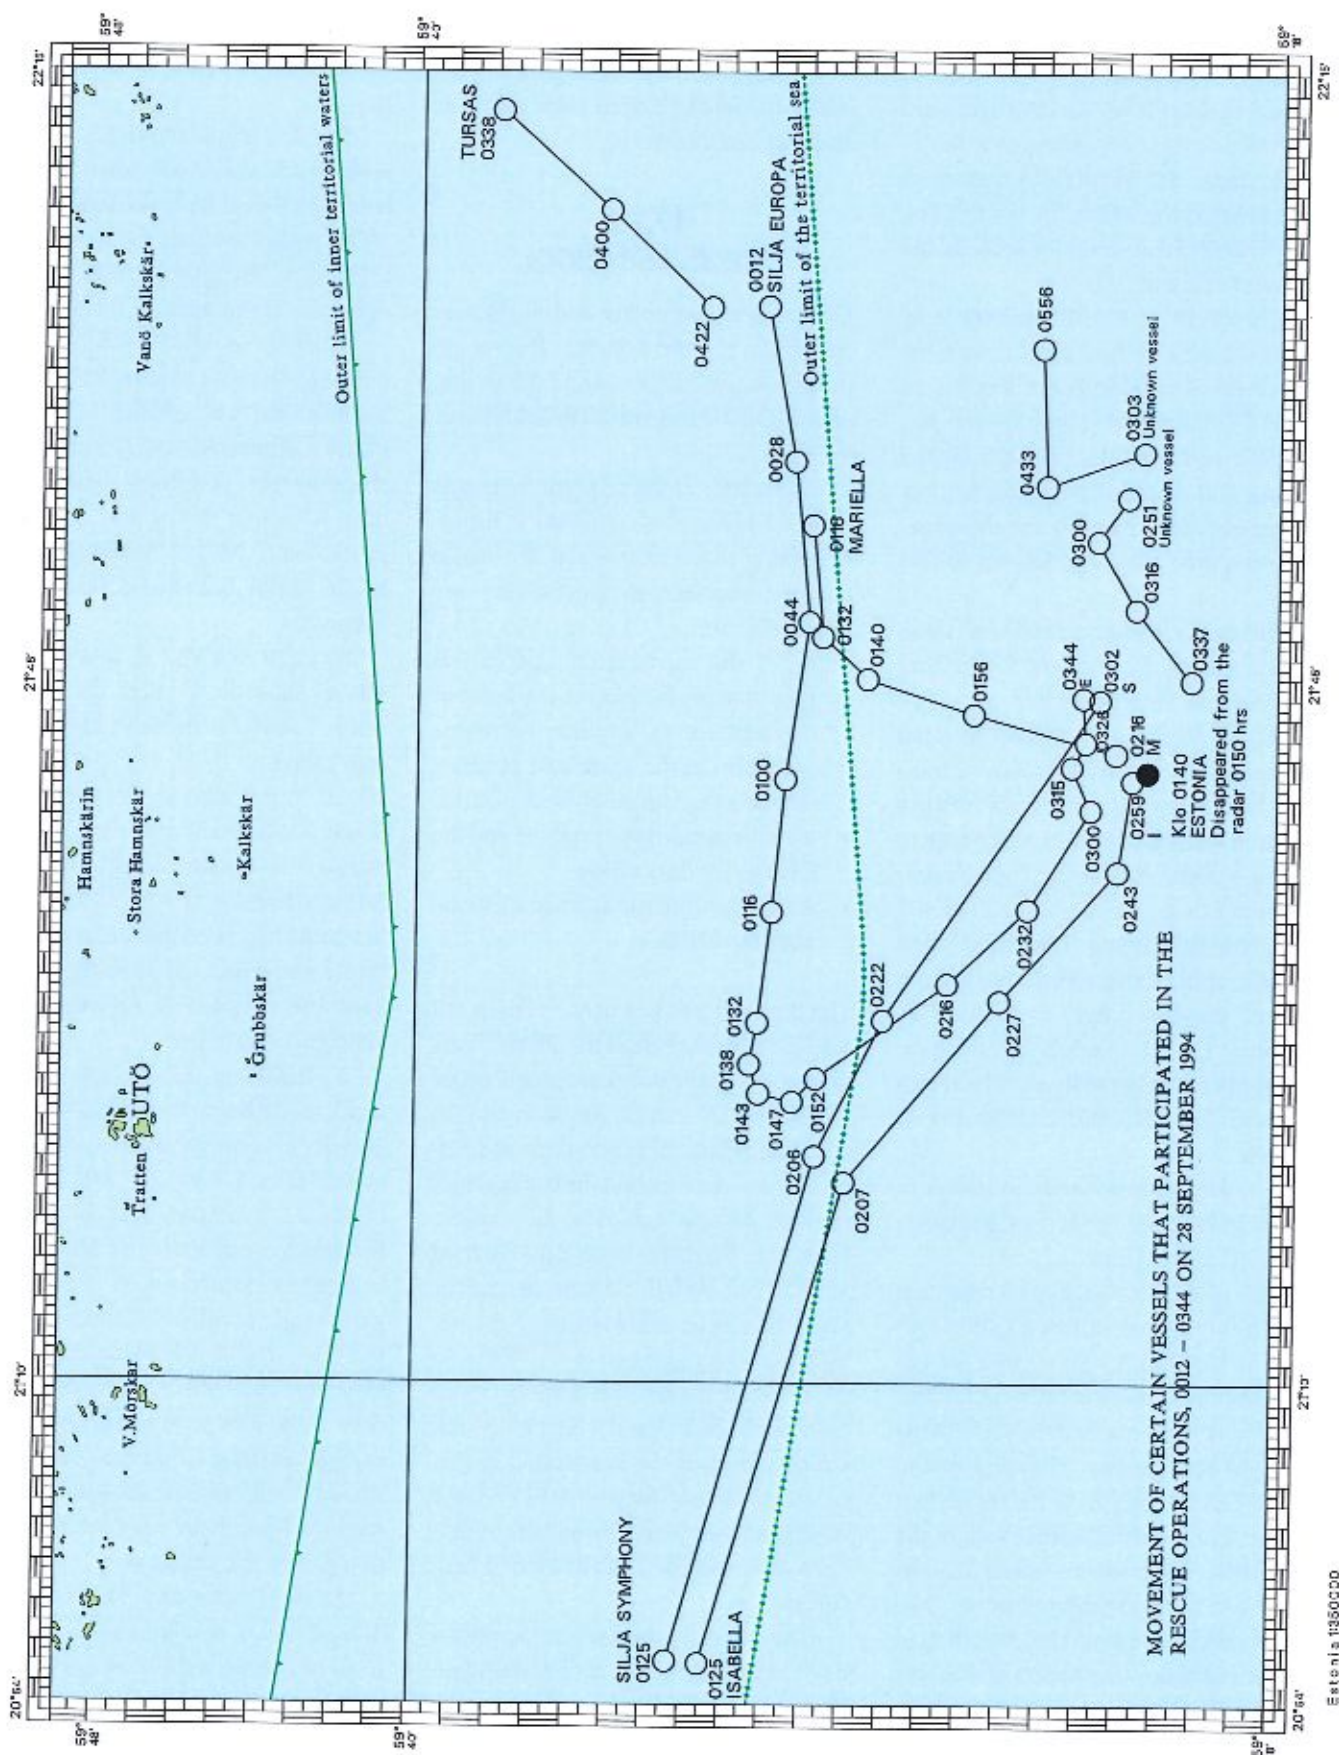
Figure 17.1 Vessel's tracks during the accident and rescue operation.

Figure 17.1 shows tracks of some vessels during the accident. The tracks are based on radar observations.

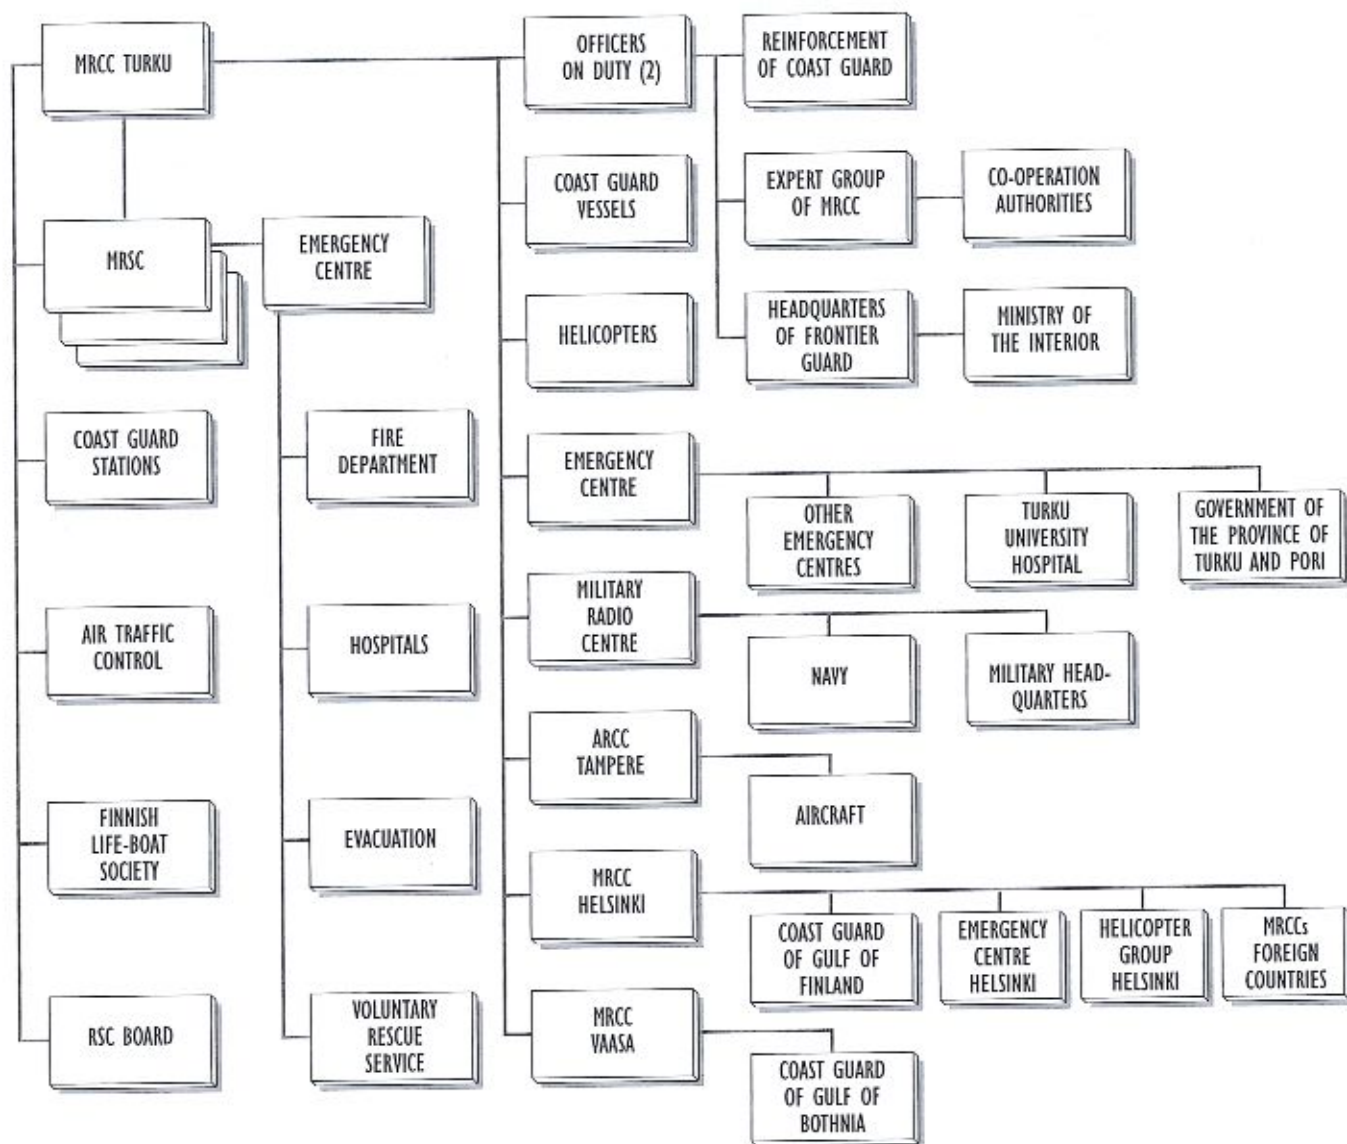
Figure 17.2 Alerting plan for Major Maritime Accident at MRCC Turku at the time of the accident.

The accident took place within the rescue region of MRCC Turku. The rescue plan for major maritime accidents at that time included the alerting schedule shown in Figure 17.2.

and the manning were inappropriate for coping with an accident of this magnitude. For this reason the rescue plan for major maritime accidents was not fully complied with. Among other things the summoning of MRCC Turku personnel was delayed. Further, MRCC Turku did not announce on the radio that they were conducting the rescue operation.

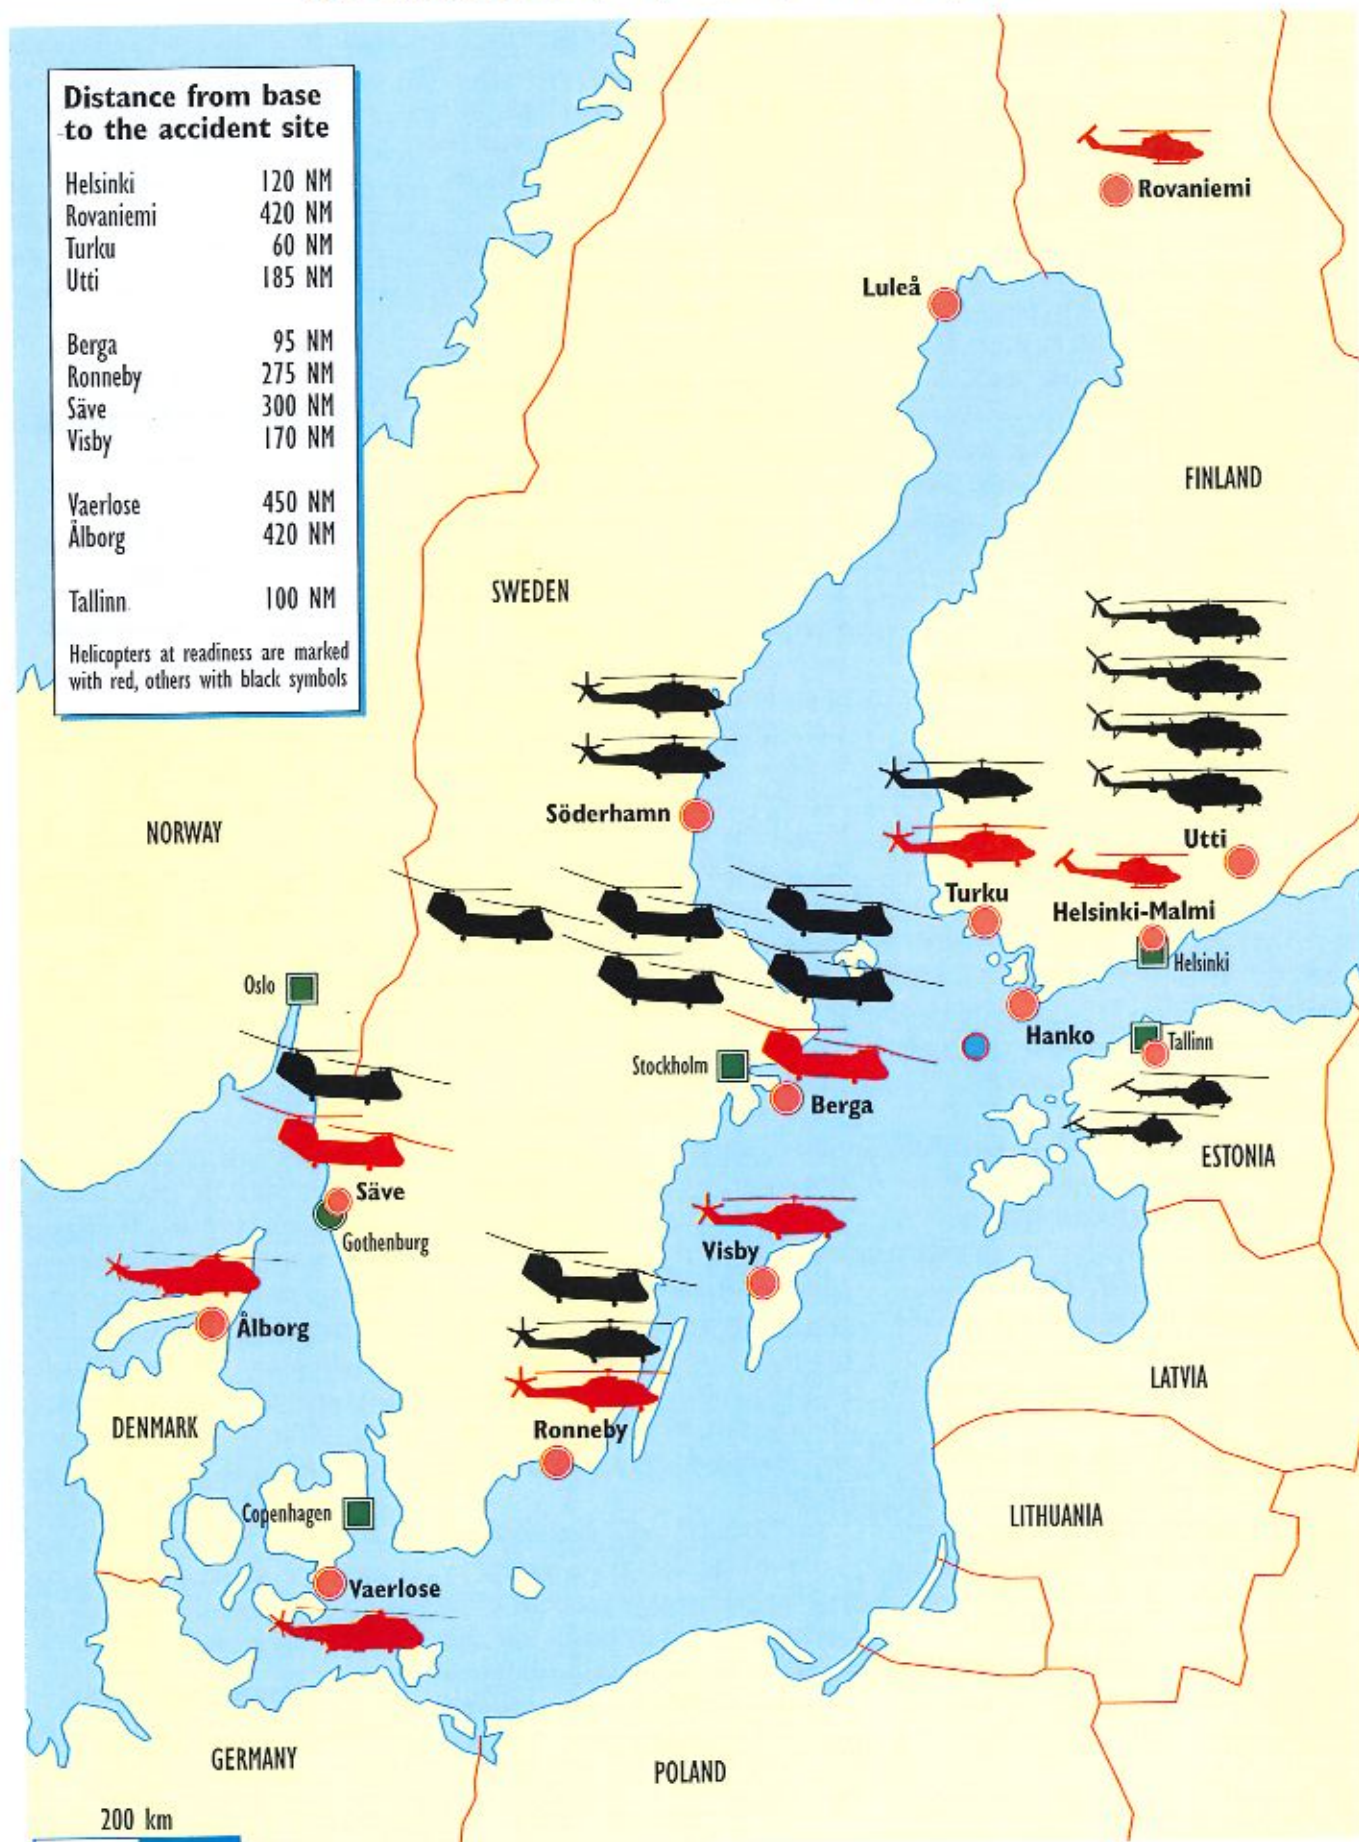
Figure 17.3 Bases of helicopters participating in the rescue operation.

The Gulf of Finland and the Northern Baltic form a significant focus for maritime rescue services since on the average 34,000 passengers cross this small sea area every day. The Helsinki, Turku and Berga helicopter bases are on the fringes of this area (Figure 17.3). Any passenger vessel using the main ship routes can be reached from these bases in less than two hours. The location of the Turku base at the half-way point of the main route is considered appropriate, although the best accessibility and the shortest flight time would be from the Hanko peninsula.

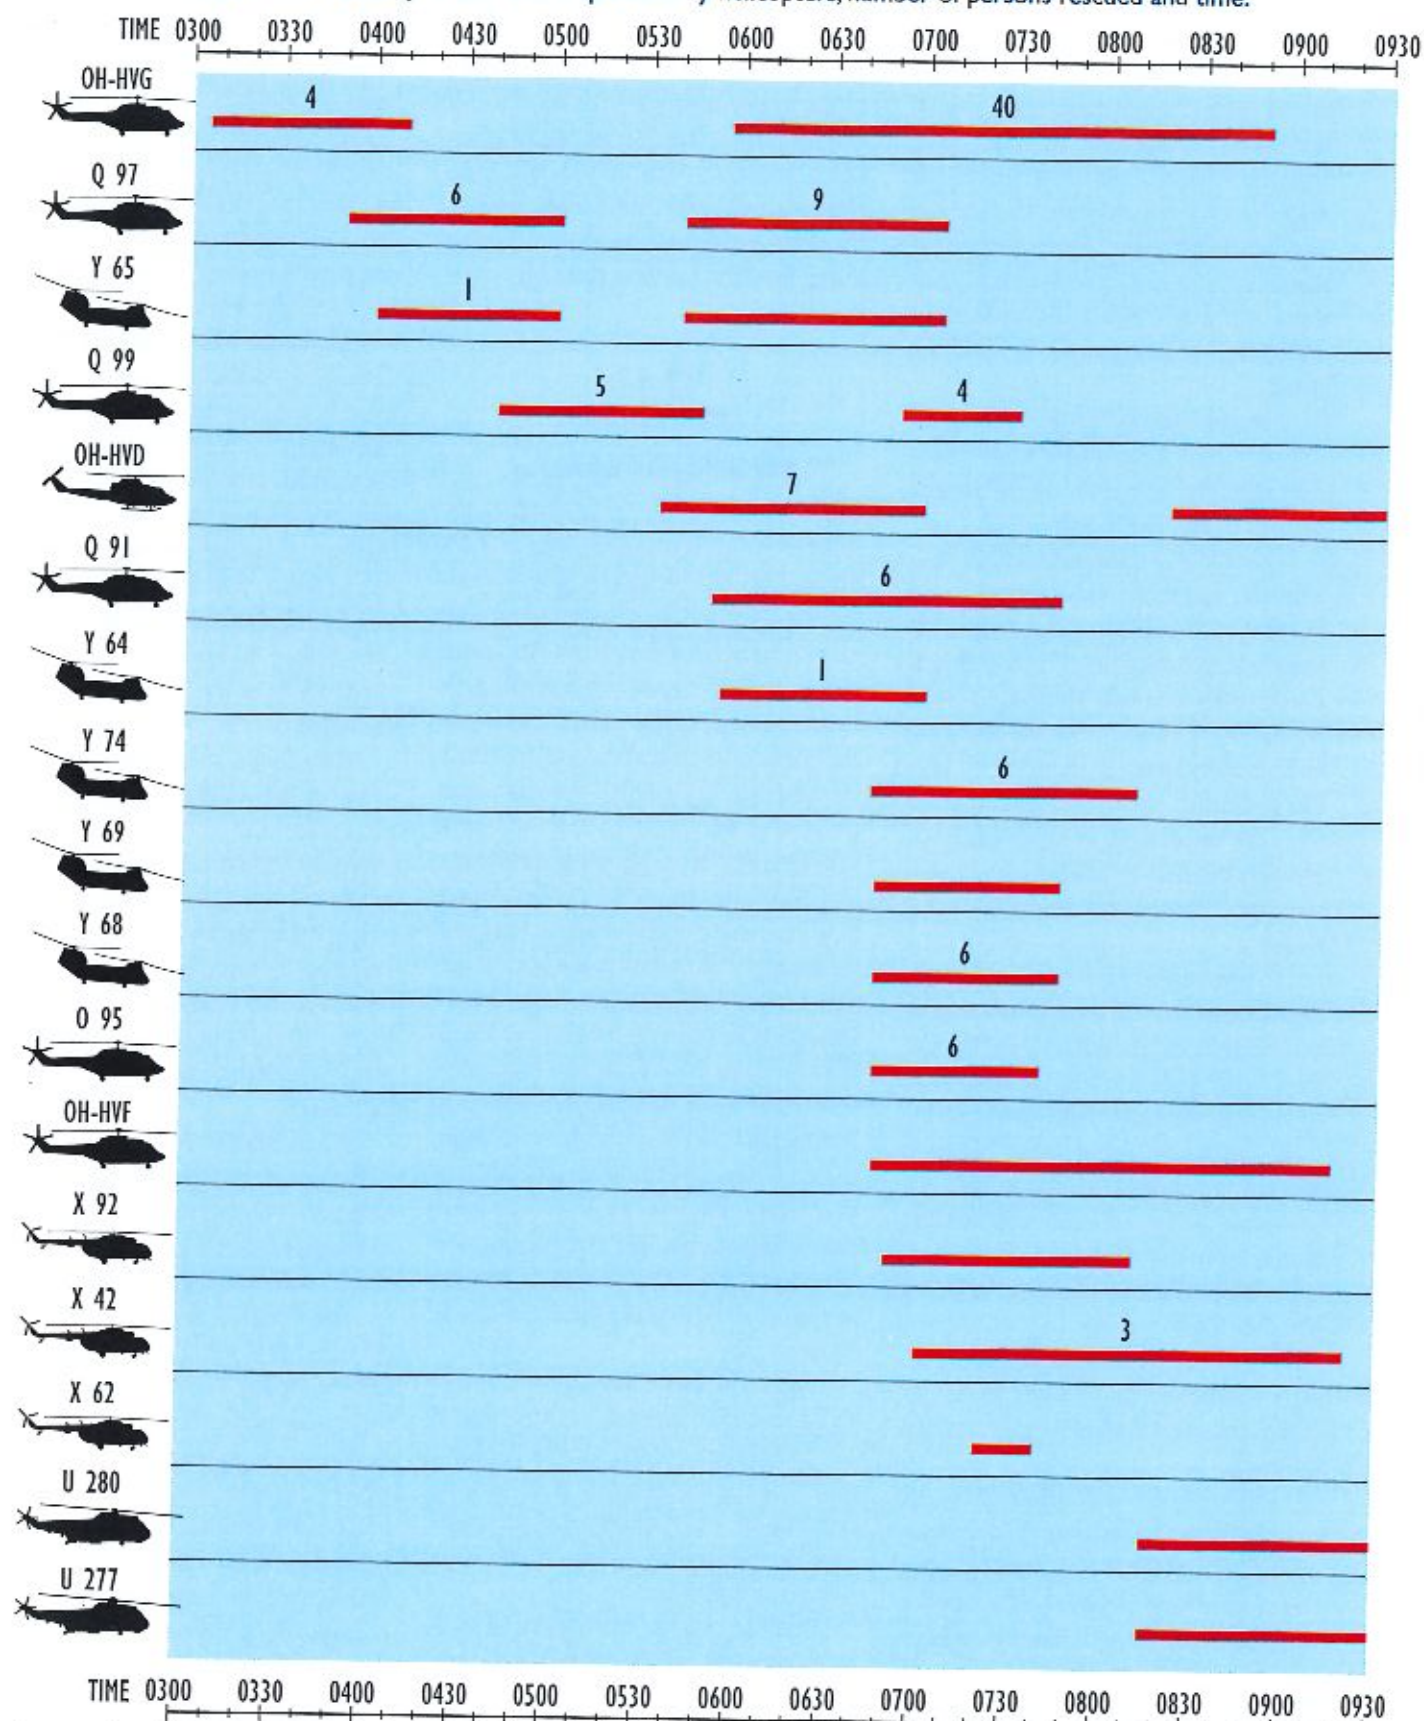
Figure 17.4 Summary of the rescue operation by helicopters, number of persons rescued and time.

The diagram in Figure 17.4 shows the number of helicopters at the scene at different times, and the numbers of survivors rescued. The diagram is partly based on estimates. Since the times at which survivors were winched were not logged, the numbers rescued during an individual flight have been distributed evenly over the entire flight time. Helicopters are considered to have been in the area of the accident even when they were transporting survivors to a vessel or to Utö. Helicopters flying survivors further than this are deemed to have left the
