## **Report RL 2000:36e**

***Accident with aircraft SE-INI  
At the Gällivare Airport,  
BD County, Sweden  
On 22 November 1999***

**Case L-104/99**

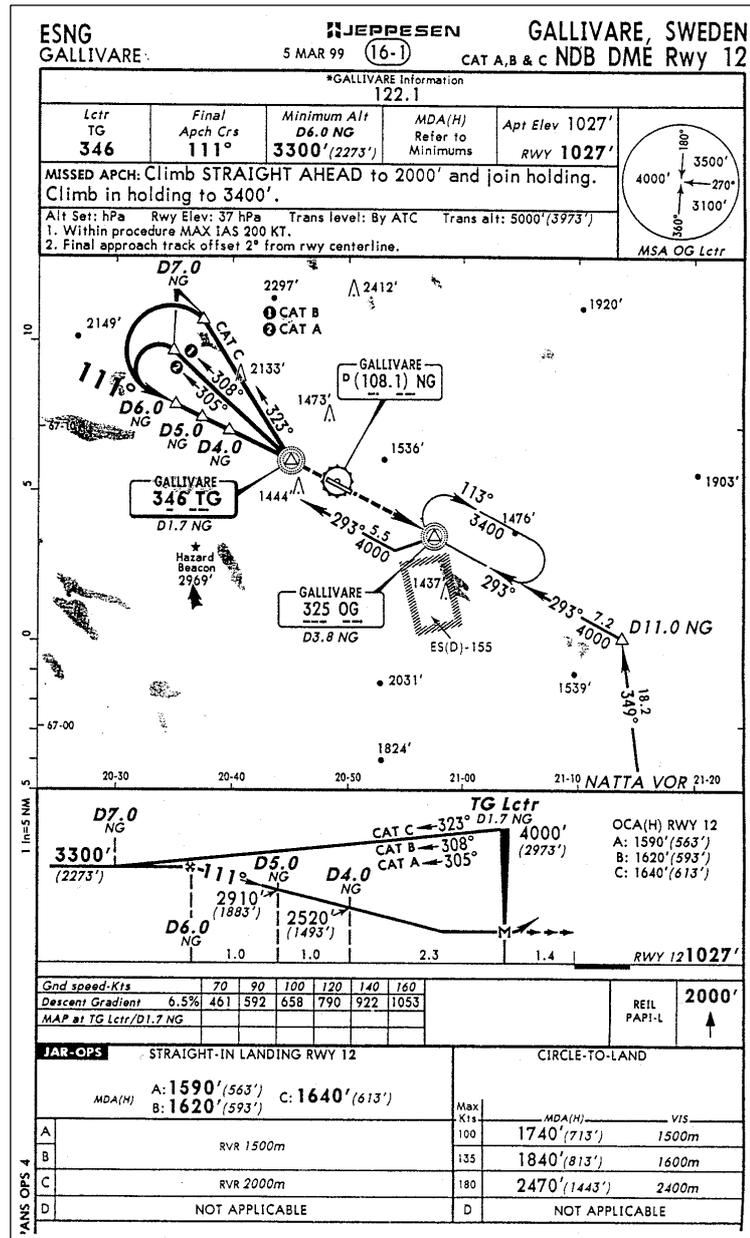
The Instrument Approach Procedure chart used. (Including landing aids, visual ground aids etc.)

Runway 12 at the Gällivare airport (ESNG) was equipped with NDB and DME<sup>5</sup>. The aircraft was equipped for instrument flight. A full procedure NDB/DME approach flown under IMC<sup>6</sup>.
