Statens haverikommission
Swedish Accident Investigation Board

Report RM 2005:01e

**Accident involving helicopter type 11 no 334
(Agusta Bell 412HP)
over Bottensjön, Karlsborg, O county, Sweden,
on 25 March 2003.**

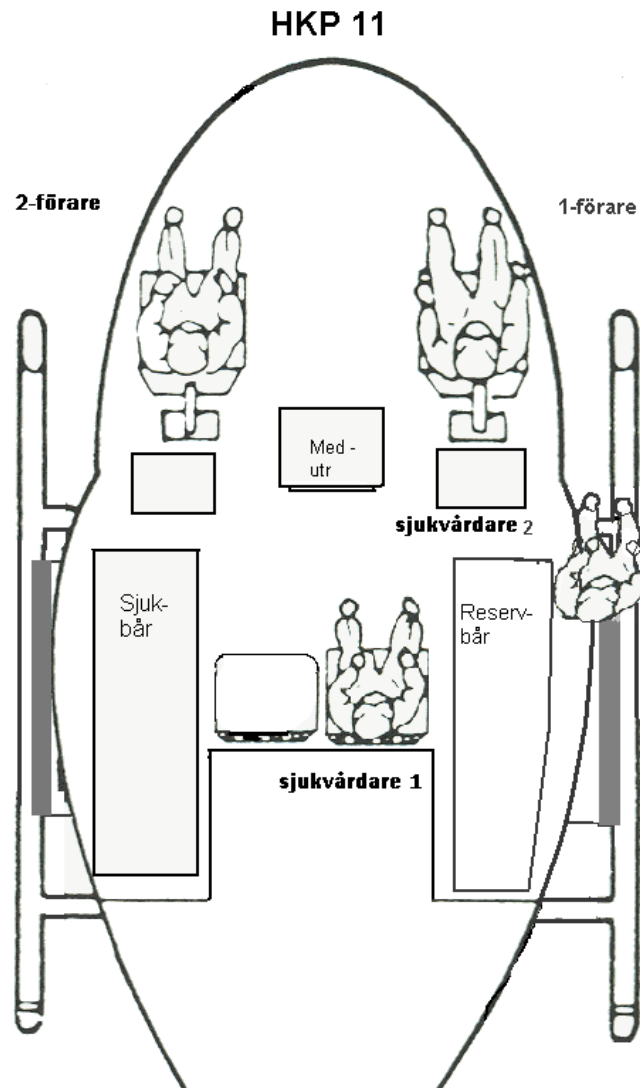
- 1. förare = Commander
- 2. förare = Co-pilot
- Sjukvårdare 1 = Medical orderly 1
- Sjukvårdare 2 = Medical orderly 2
- Med.utr. = Medical equipment
- Sjukbår = Stretcher
- Reservbår = Reserve stretcher
